REPORT
OF THE
TECHNICAL ASSESSMENT PANEL

COLLAPSE OF THE 300 foot RADIO TELESCOPE

**REPORT of the TECHNICAL ASSESSMENT PANEL
for the
300 foot RADIO TELESCOPE at GREEN BANK, WV**

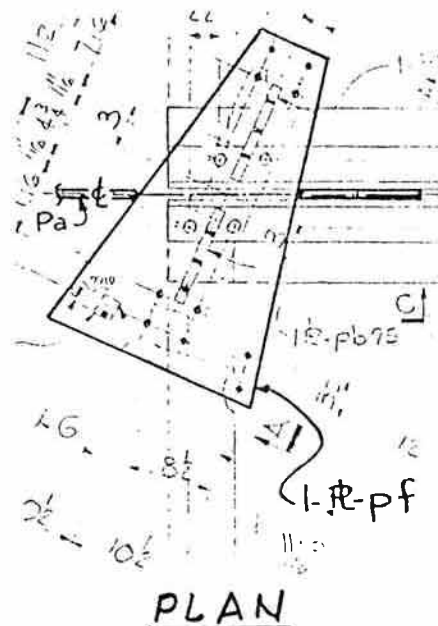
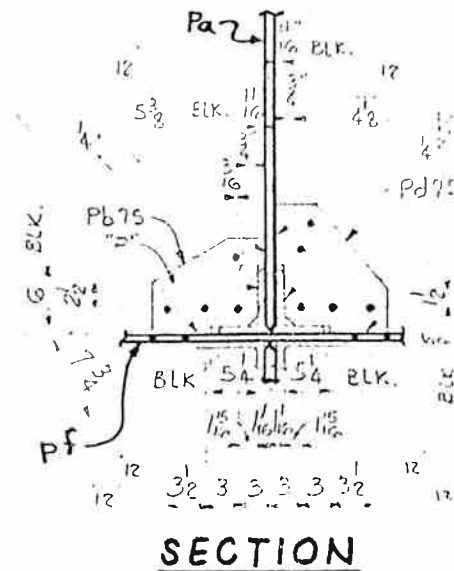
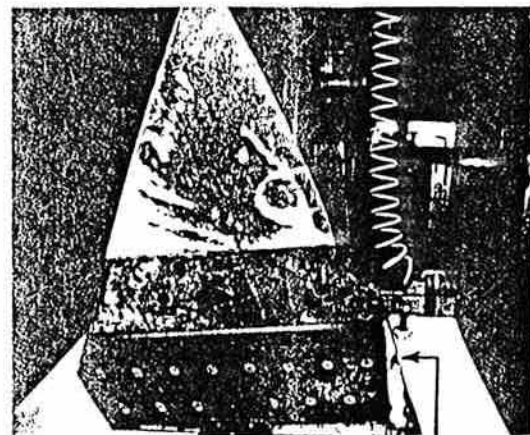
FIGURE 1-16 : RUPTURED GUSSET PLATE DETAILS

The Technical Assessment Panel concludes that the probable cause of telescope collapse was the progressive cracking of the gusset plate at the end of the lower chord of the diamond truss at the northeast corner. This lower chord at its other end intersected with the support bearing structure. The failure of the lower chord of the diamond truss in this location destroys the ability of the truss to carry load as a truss and collapse ensues. The progressive cracking was caused by excessive stress in the gusset. As calculated in the idealized state of the structure, the stress was far beyond limits which would have precluded such progressive cracking. The crack origin was probably associated with two punched bolt holes where the severe working produced by the punch could have left an initiating small crack.

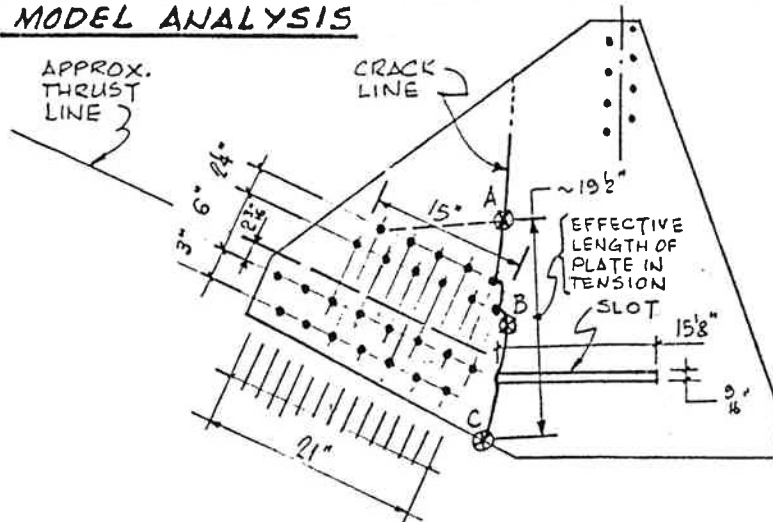
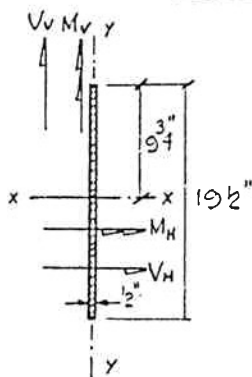
RUPTURED GUSSET PLATE ELEVATION

2) Visual inspection and laboratory tests of the ruptured gusset removed from the telescope wreckage indicated progressive cracking and eventual rupturing of this plate. The analysis showed that the plate stresses were high enough to cause cracking and crack growth under the cyclic loads from the antenna movements. Rupture of the plate would have resulted in the collapse of the telescope. It should be noted that the telescope had a history of several gusset plate replacements throughout its operational life.

AVG. BENDING STRESS FLUCTUATION = $[(117 - 28.1) + (160 - 28.1)] / 2 = 110 \text{ ksi}$ ABOVE 28.1 ksi (N&S)
(Therefore, since only the yield stress can be developed, the p will yield)

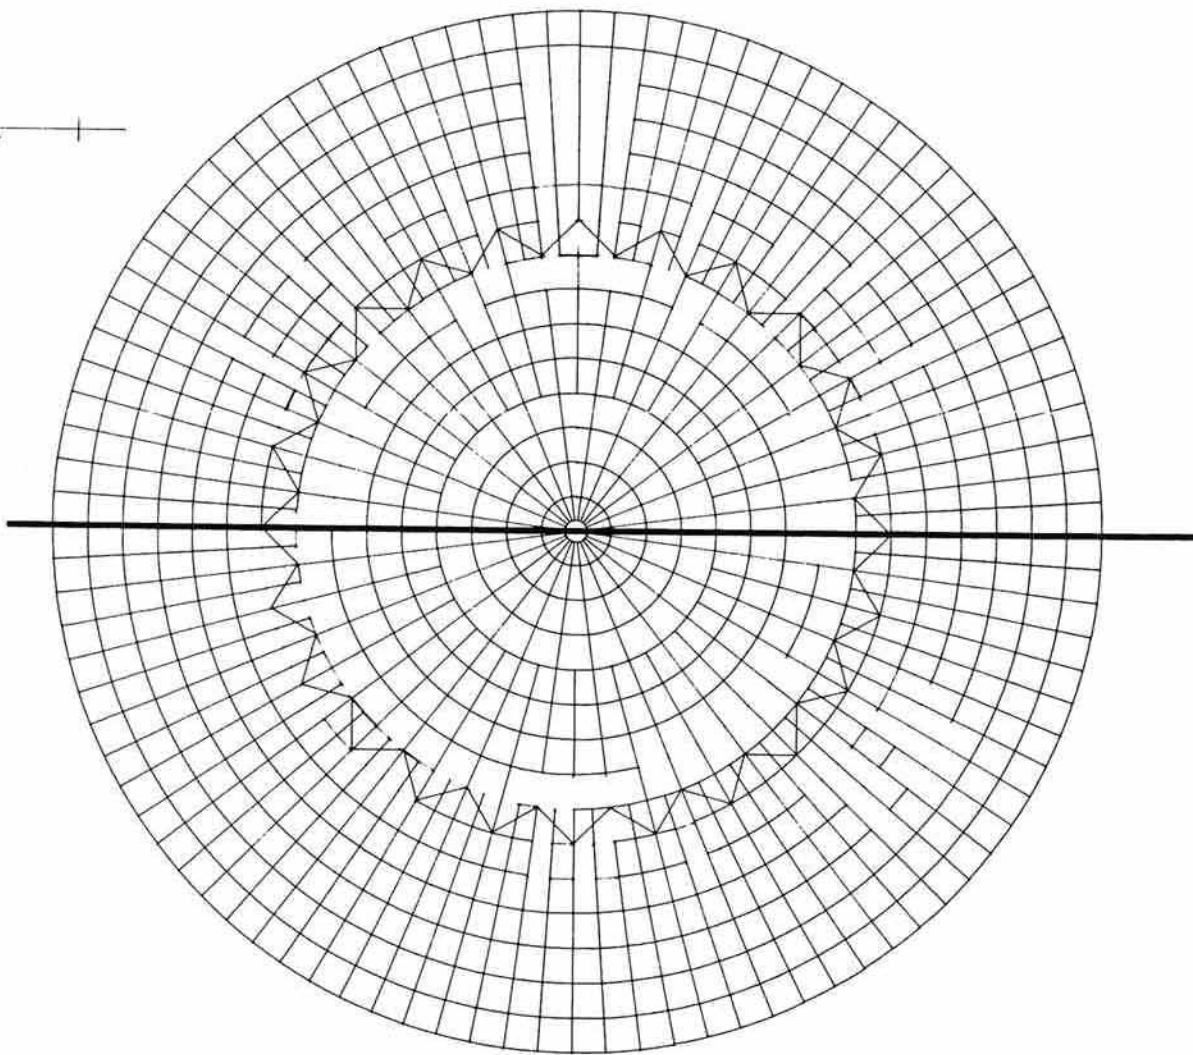
FIGURE NO. 2-10
300 FT. RADIO TELESCOPE
GREEN BANK, WV.
TOP SURFACE PROJECTION
MEMBER OVERSTRESSES,
ZENITH & 45° INCLINED DISH POSITIONS

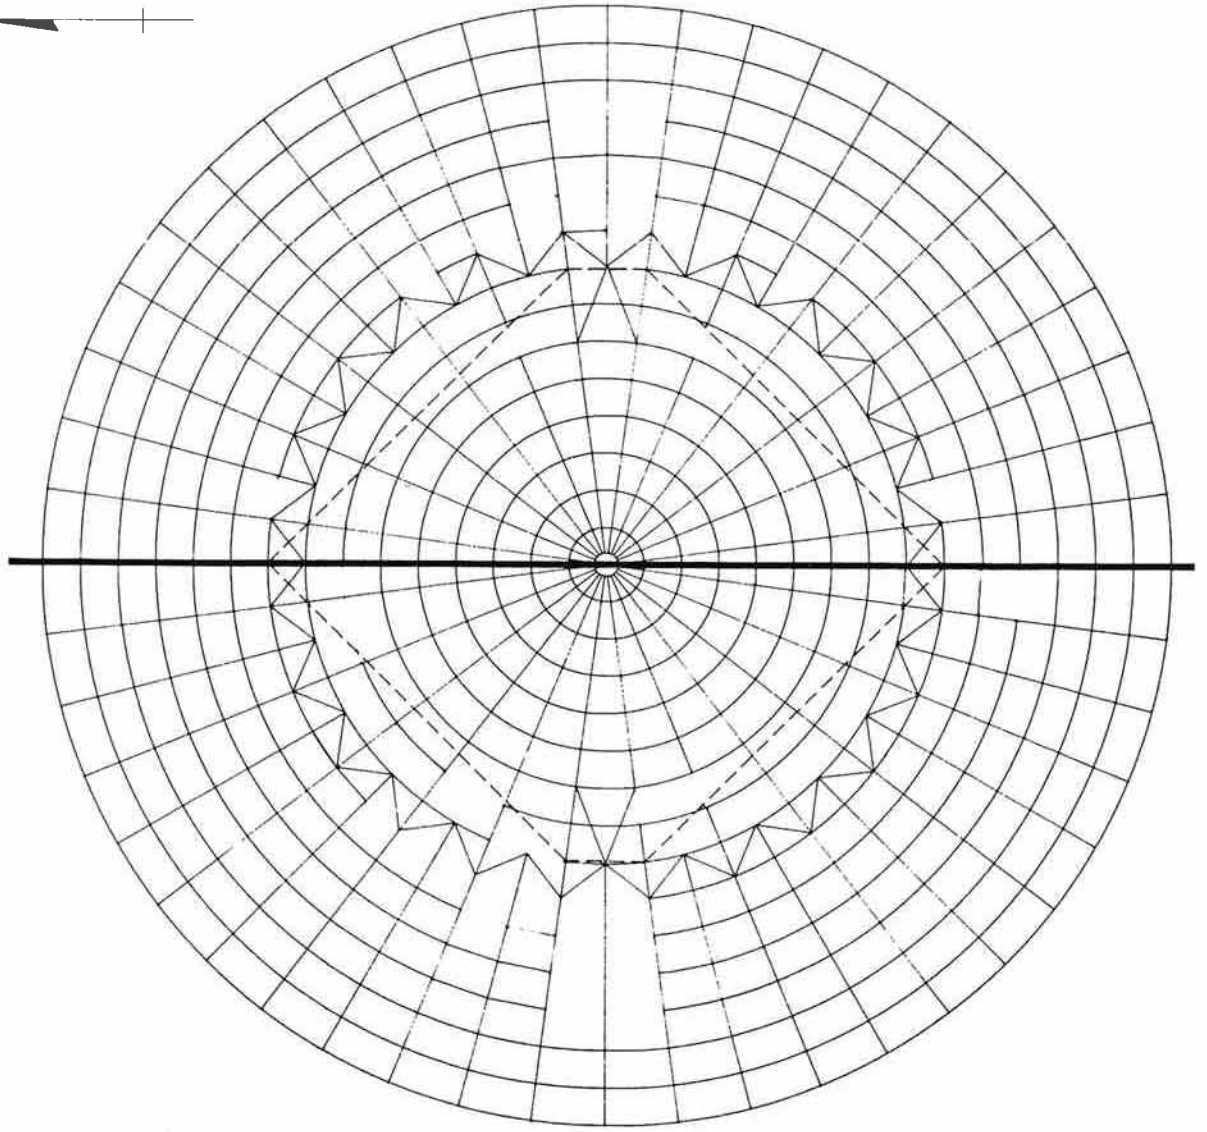
FIGURE NO. 2-11
300 FT. RADIO TELESCOPE
GREENBANK, W.V.a.
BOTTOM SURFACE PROJECTION
MEMBER OVERSTRESSES,
ZENITH & 45° INCLINED DISH POSITIONS

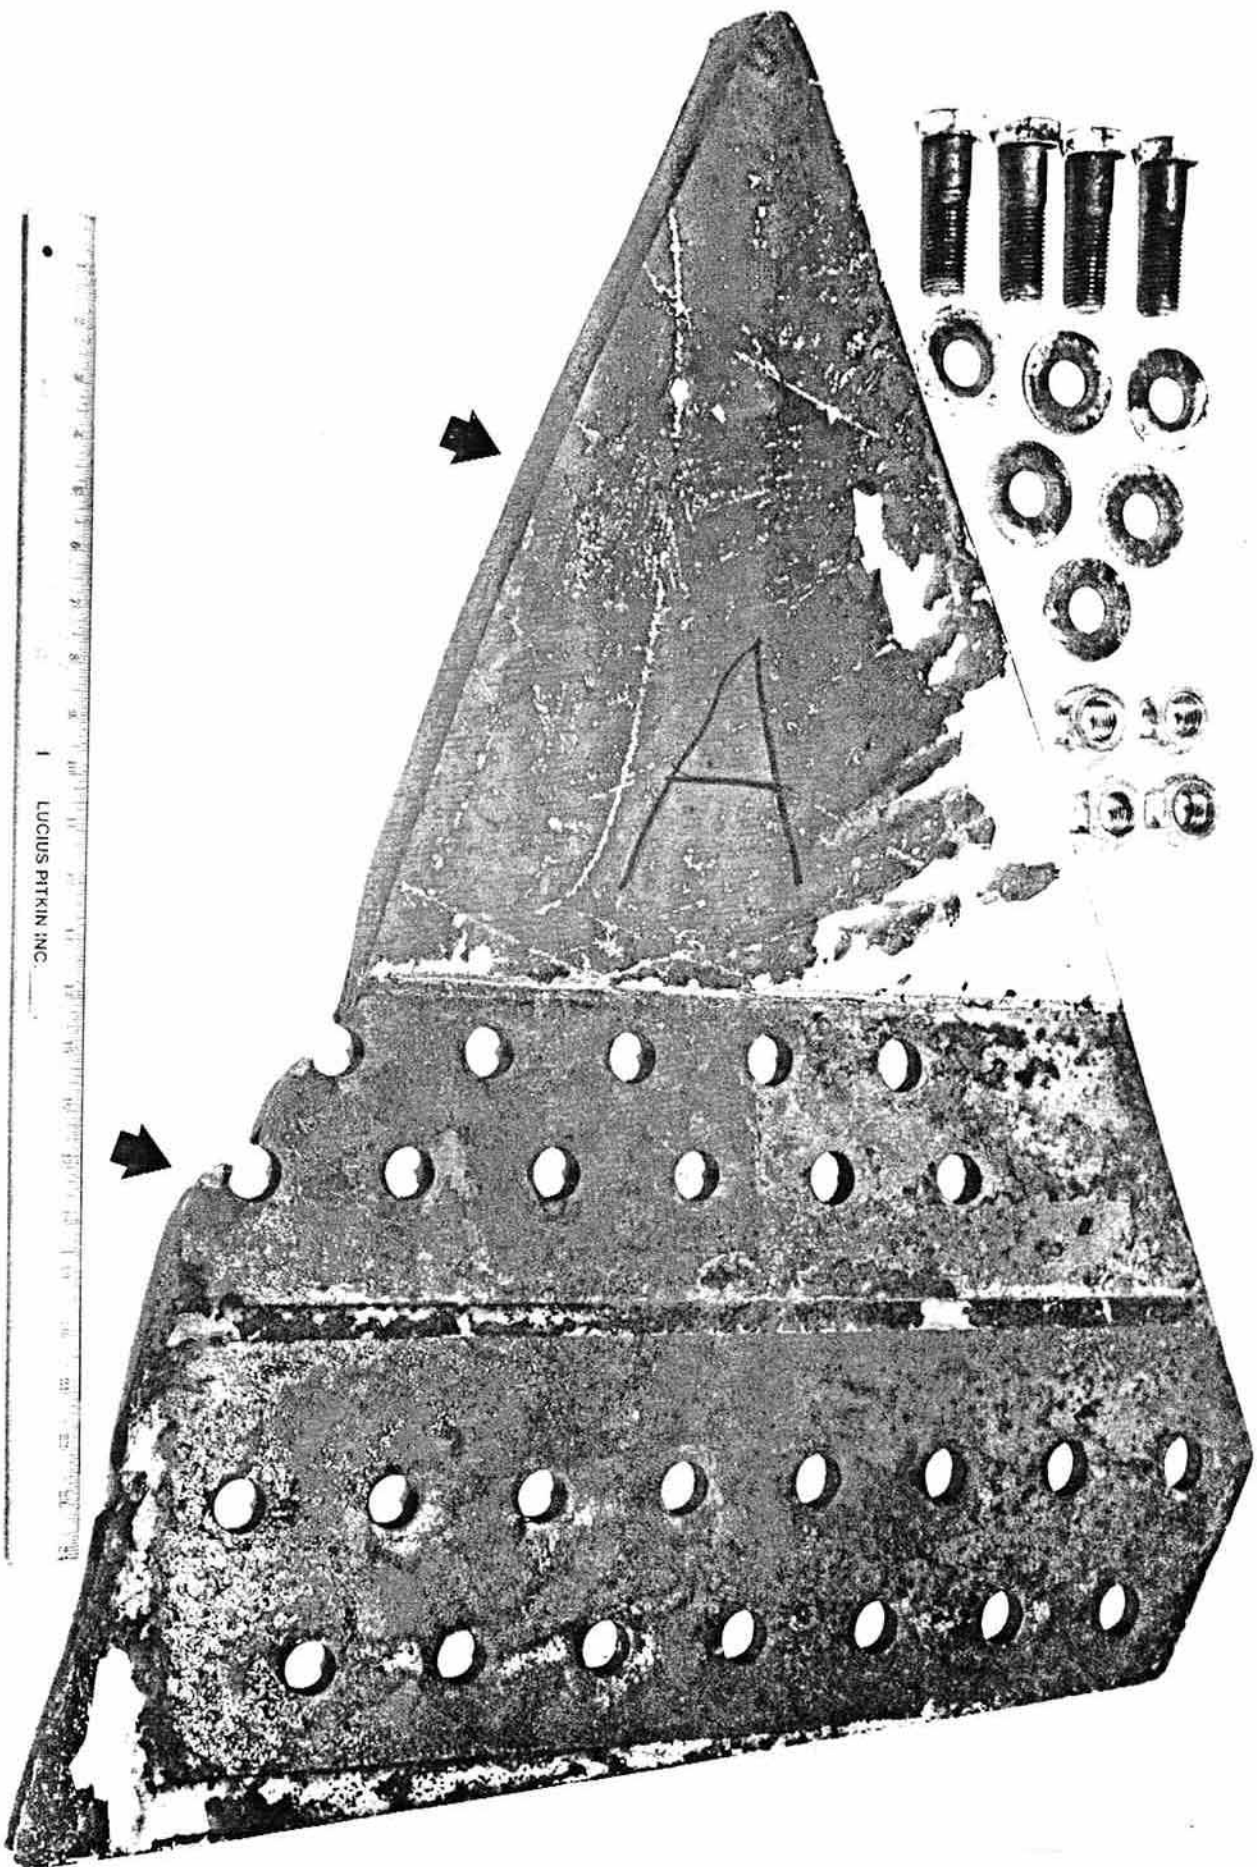
Photograph showing the submitted 1/2-in. thick main box girder plate from the 300 ft. radio telescope at Greenbank, West Virginia, in the as-received condition. The plate fracture was approximately 37 in. long (arrows) and intersected two bolt holes.

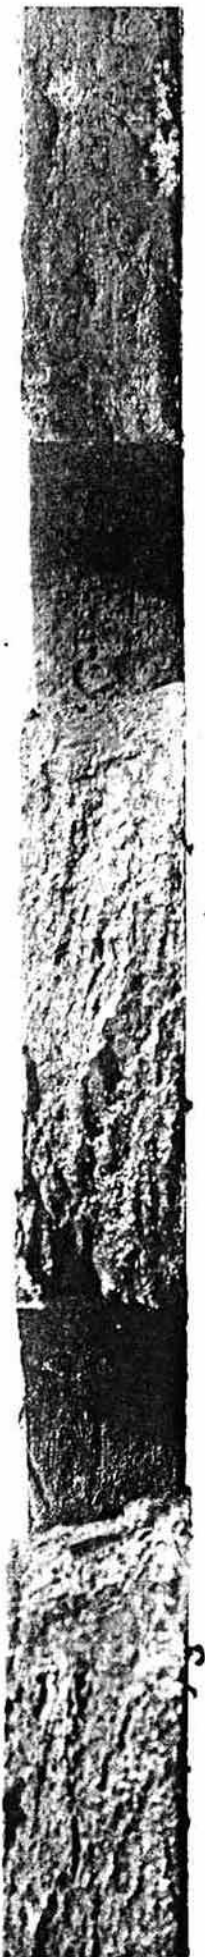
of progressive cracking in the nature of fatigue. Propagation of these fatigue cracks under cyclic loading from both bolt holes eventually resulted in a fast ductile fracture when the combination of cyclic stress range and crack size exceeded the fracture toughness of the plate material.

Photograph showing the flat and heavily oxidized appearance of the plate fracture surfaces adjacent to the bolt holes. This flat and heavily oxidized fracture appearance is characteristic of long-term progressive or fatigue cracking. The convergence of chevron-like marks indicates the bolt holes to be the fracture origins.

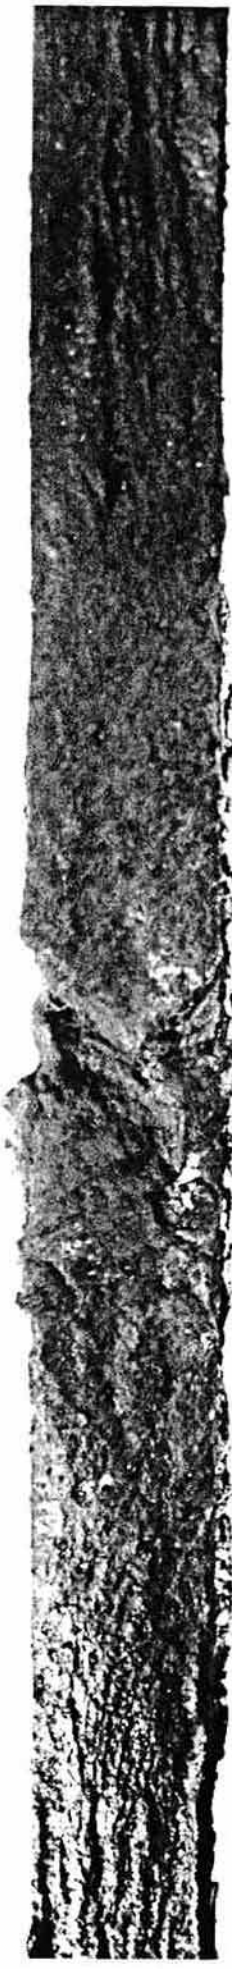
Photograph showing a weld deposit/splatter or arc gouge discontinuity in the fracture plane approximately midway between the bolt holes and the short edge of the plate. The lack of converging chevron-like marks near this discontinuity indicated it was not a primary fracture origin.

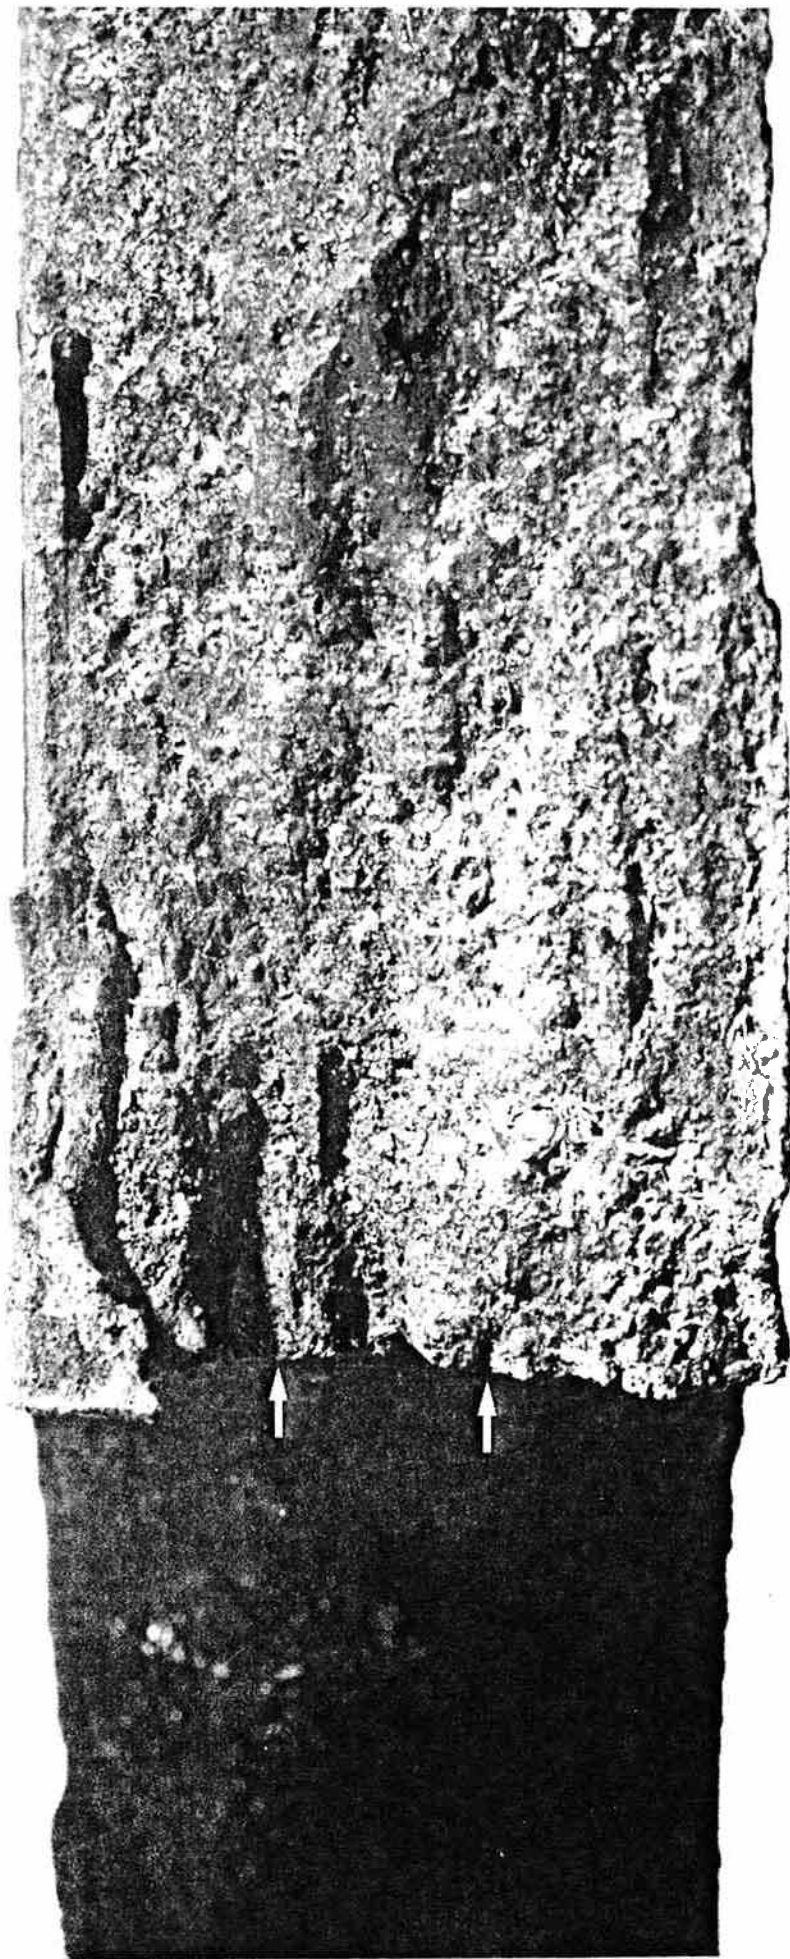
Close-up photograph showing the presence of fracture surface ratchet marks (arrows) at the bolt hole surfaces, as is characteristic of progressive crack initiation in the nature of fatigue.

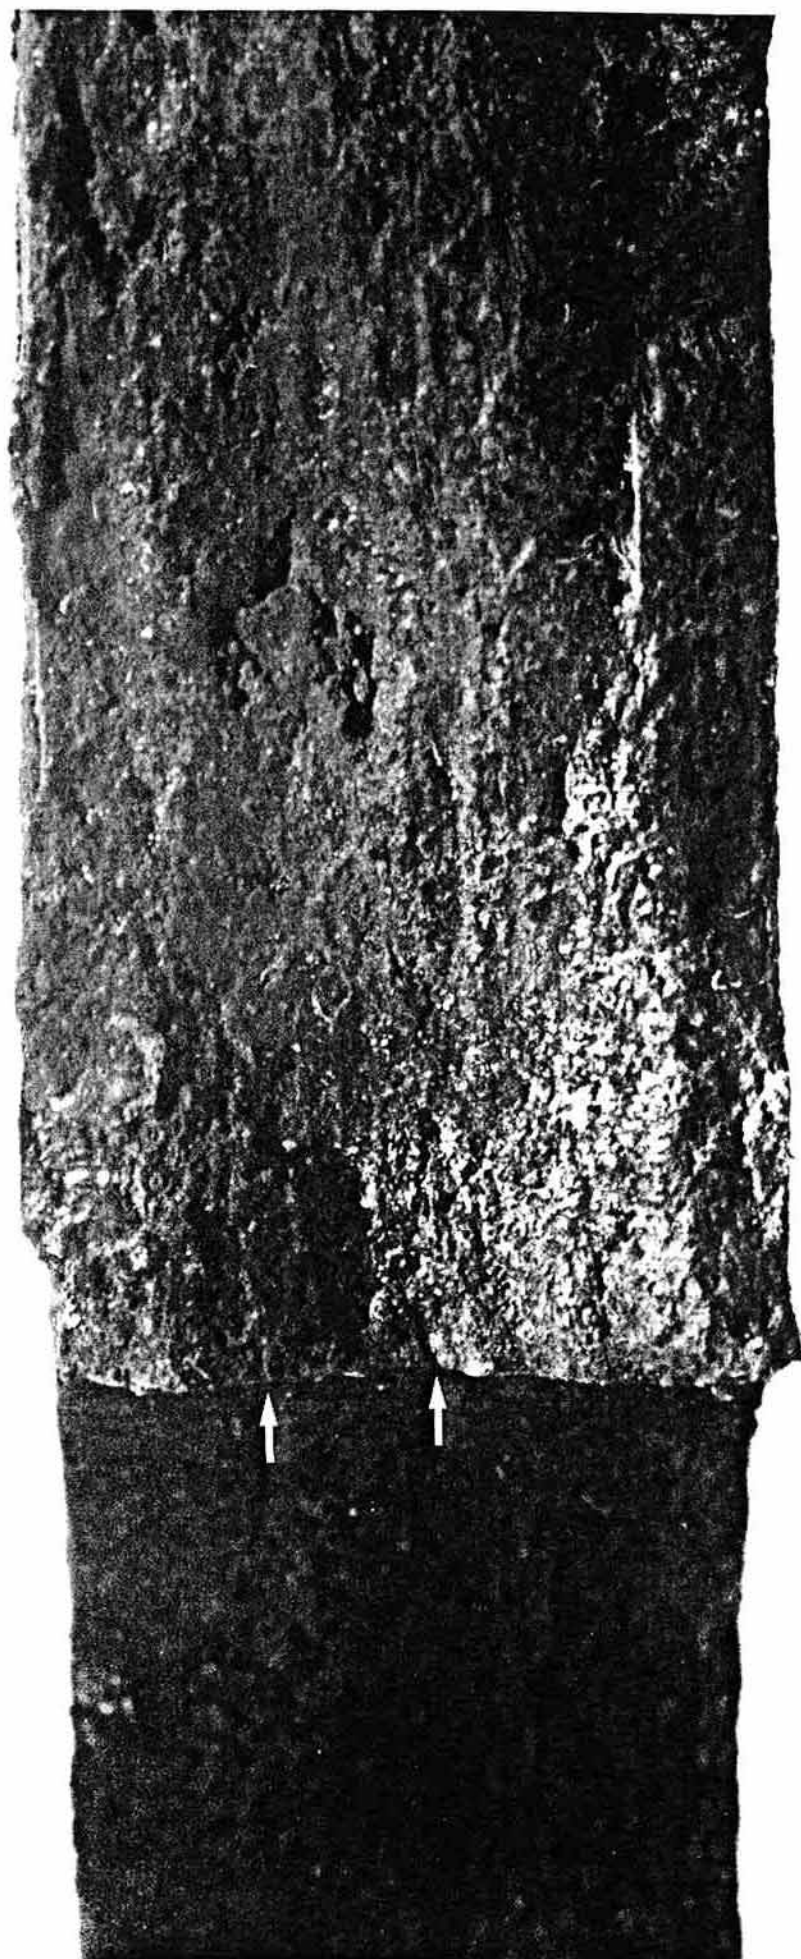
Close-up photograph showing the presence of fracture surface ratchet marks (arrows) at the bolt hole surfaces, as is characteristic of progressive crack initiation in the nature of fatigue.

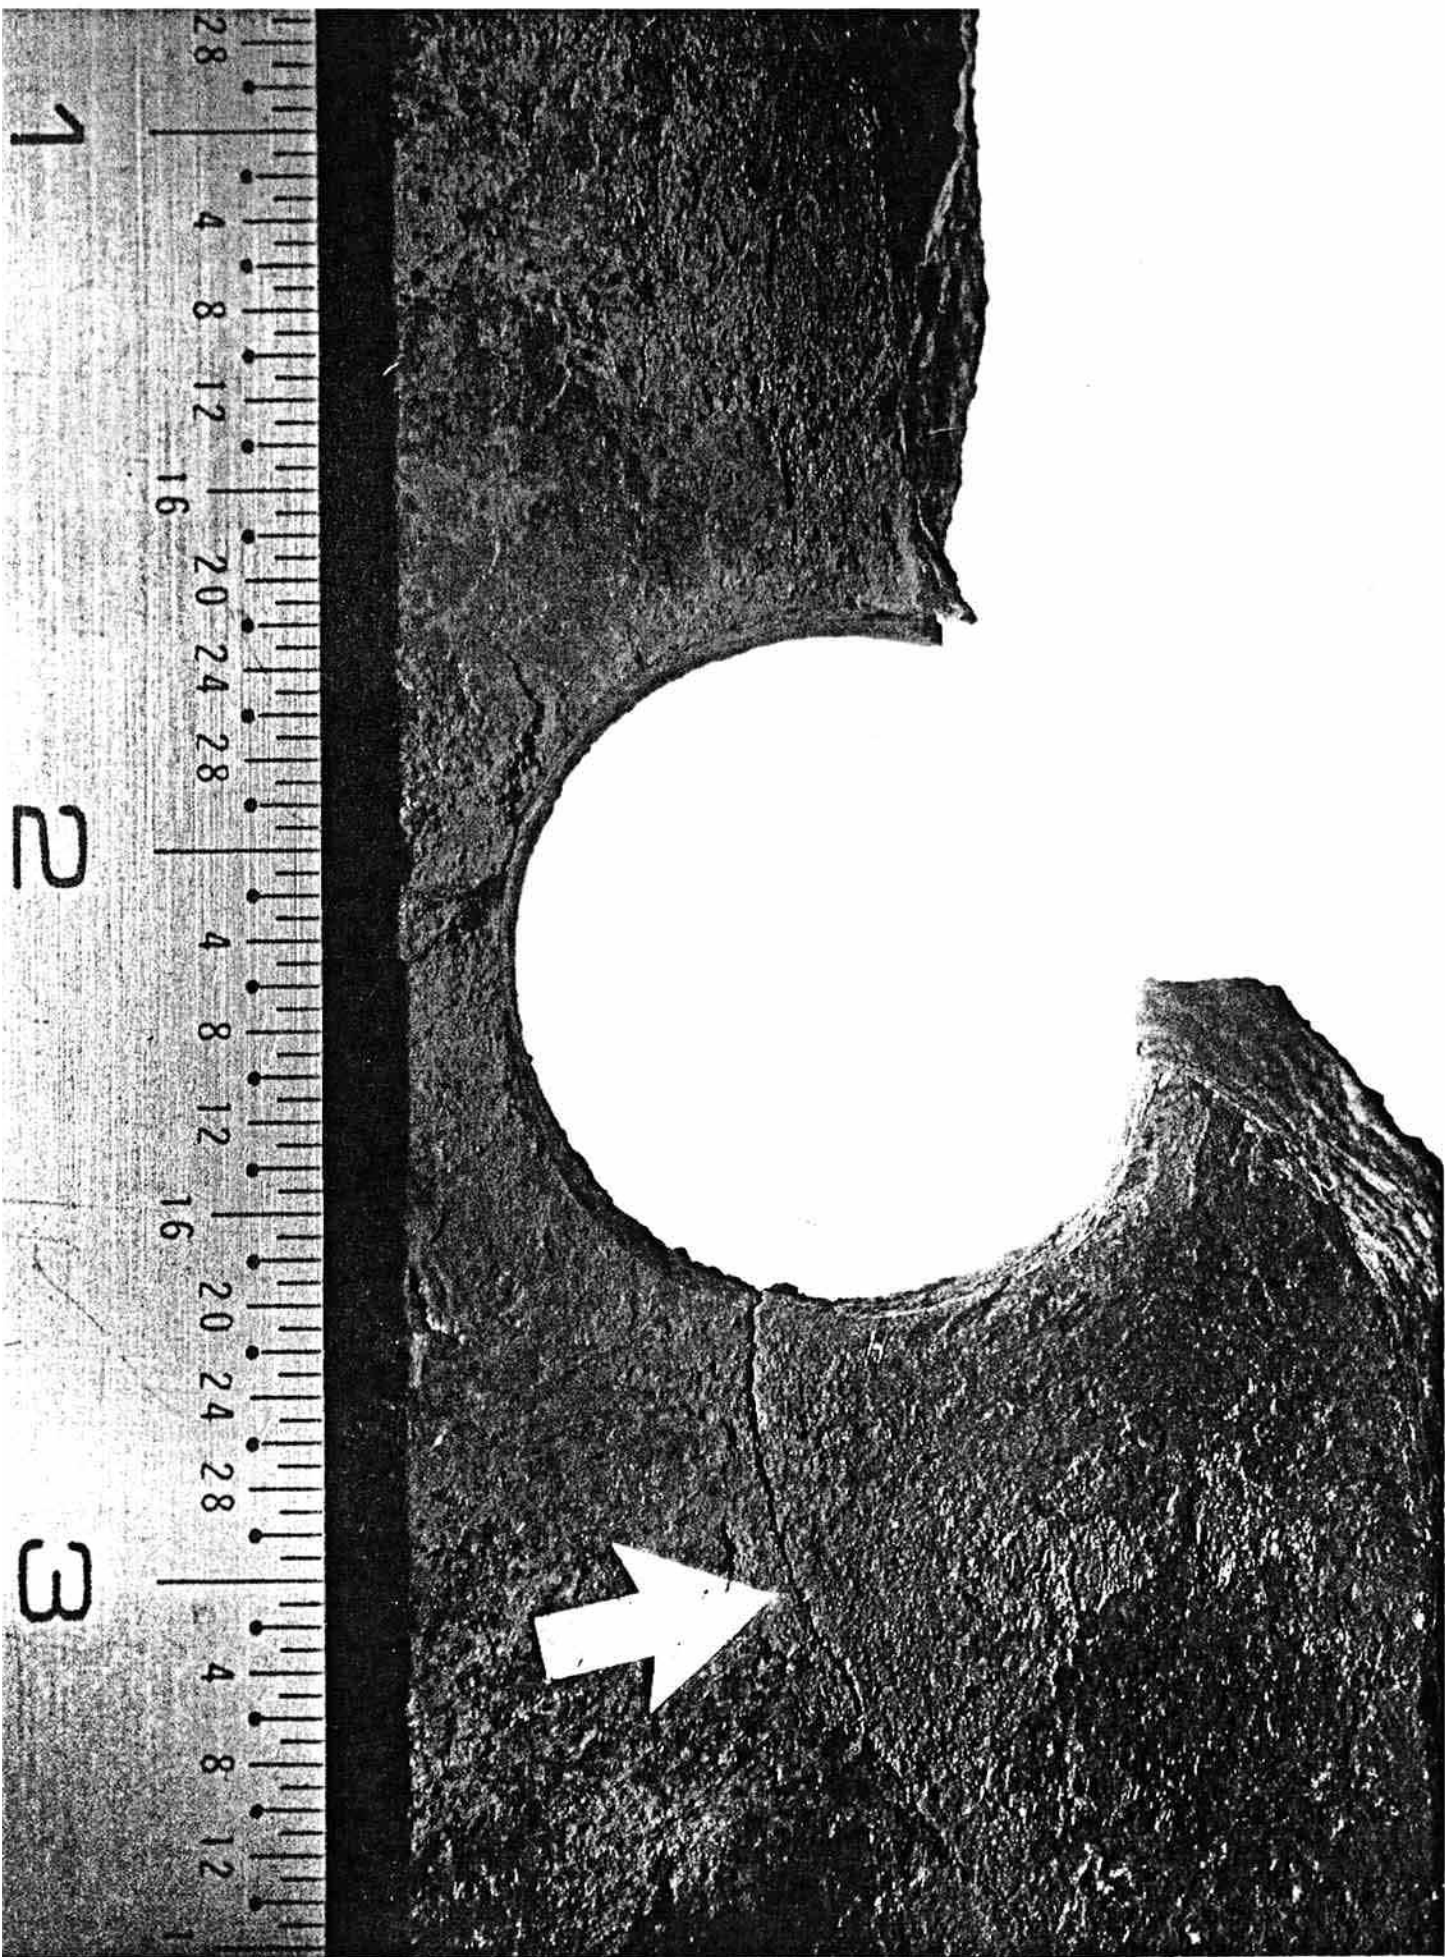
The results of the fractographic examination revealed secondary fatigue cracks also had originated at the bolt hole surfaces. The presence of secondary fatigue cracks at the bolt holes indicates the presence of intermediate to high cyclic stresses.

Close-up photograph showing a secondary fatigue crack (arrow) parallel and adjacent to the primary fracture, as is characteristic of fatigue cracking under intermediate to high cyclic stresses.

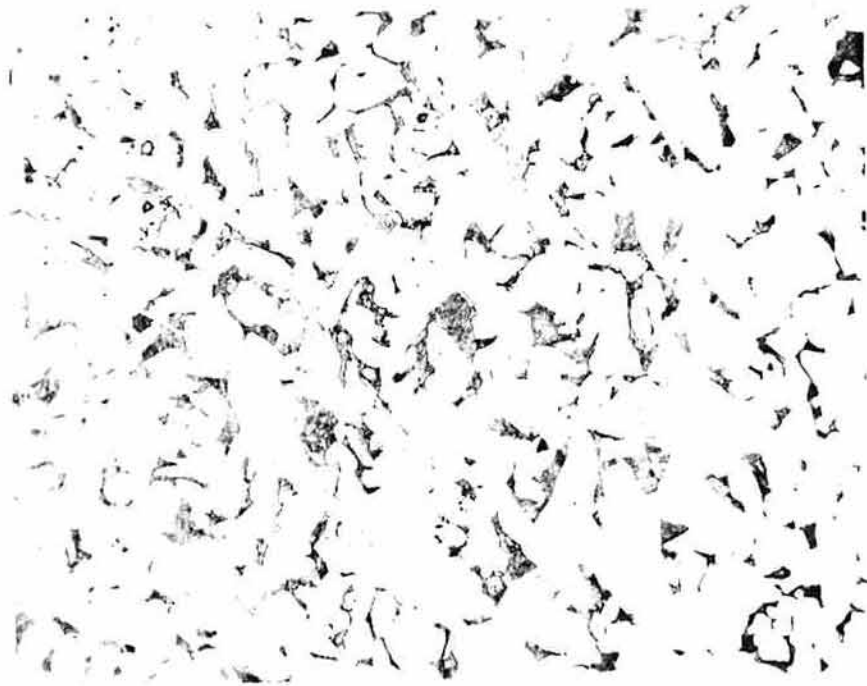
Fig. 8

GENERAL MICROSTRUCTURE

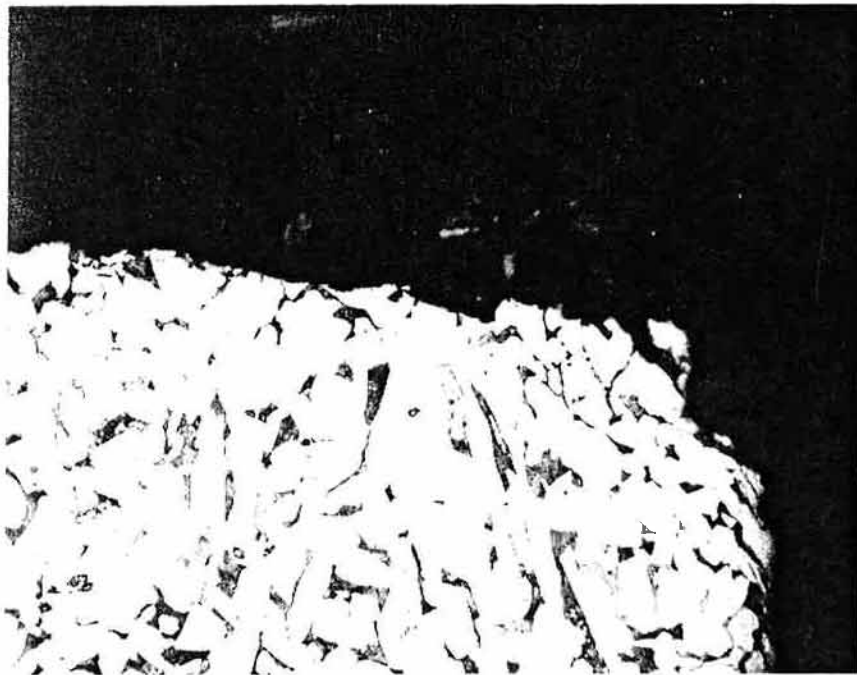
Fig. 9

FRACTURE PROFILE AT ORIGIN

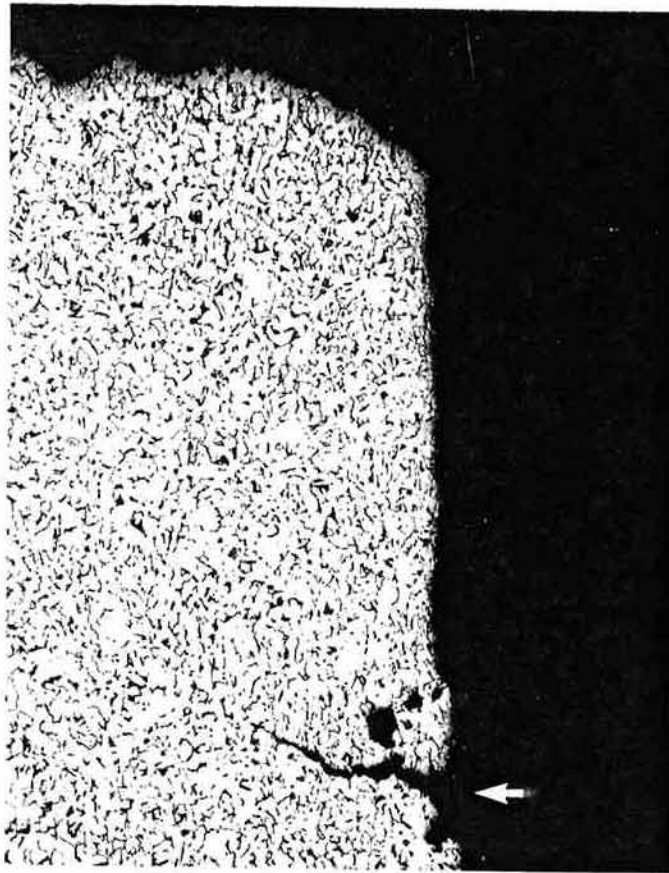
Fig. 10

SECONDARY FATIGUE CRACK

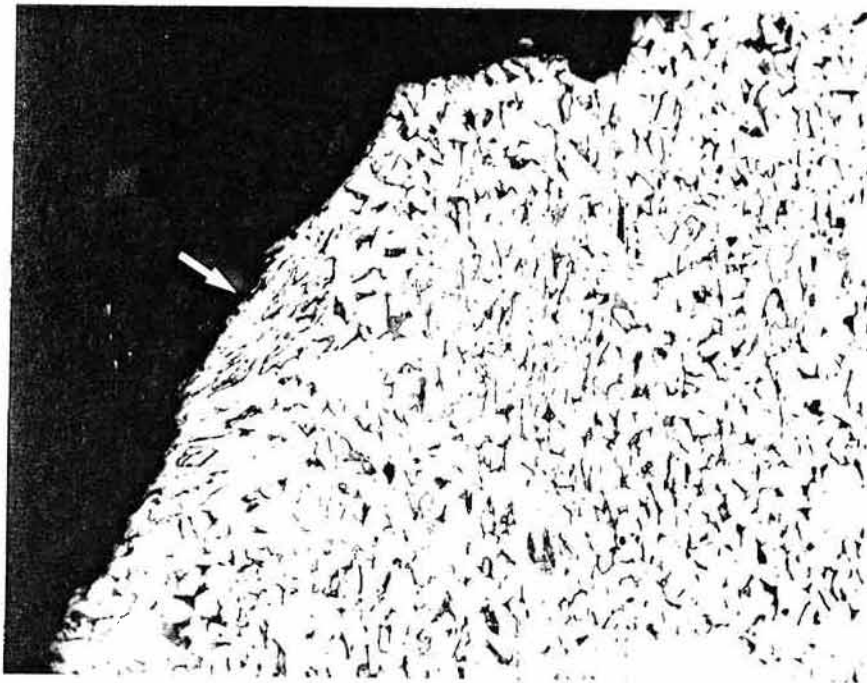
Fig. 11

FRACTURE PROFILE REMOTE
FROM BOLT HOLE ORIGIN

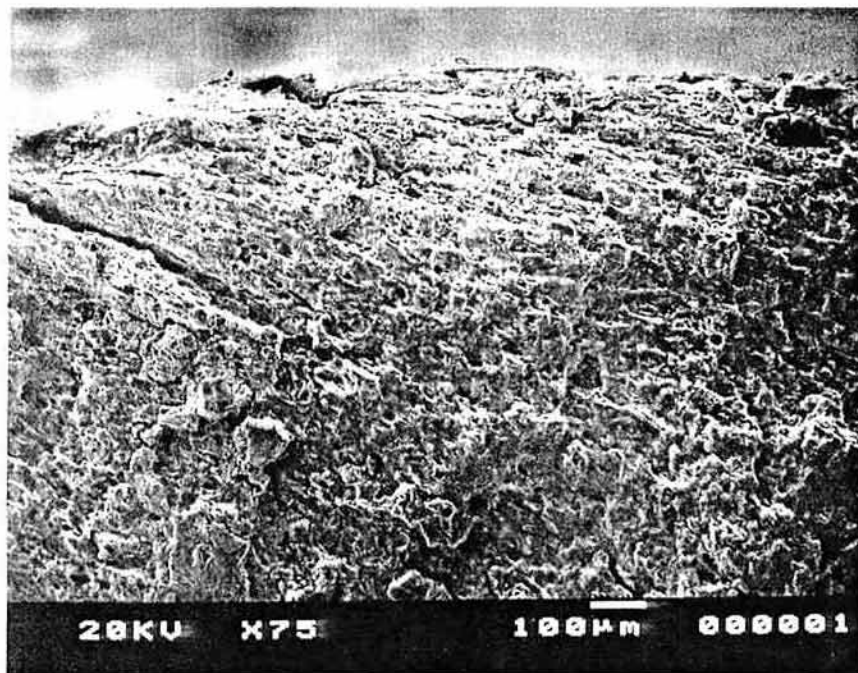
Fig. 12

FRACTURE ORIGIN AT ORIGIN
