REPORT
OF THE
TECHNICAL ASSESSMENT PANEL

COLLAPSE OF THE 300 foot RADIO TELESCOPE

**REPORT of the TECHNICAL ASSESSMENT PANEL
for the
300 foot RADIO TELESCOPE at GREEN BANK, WV**

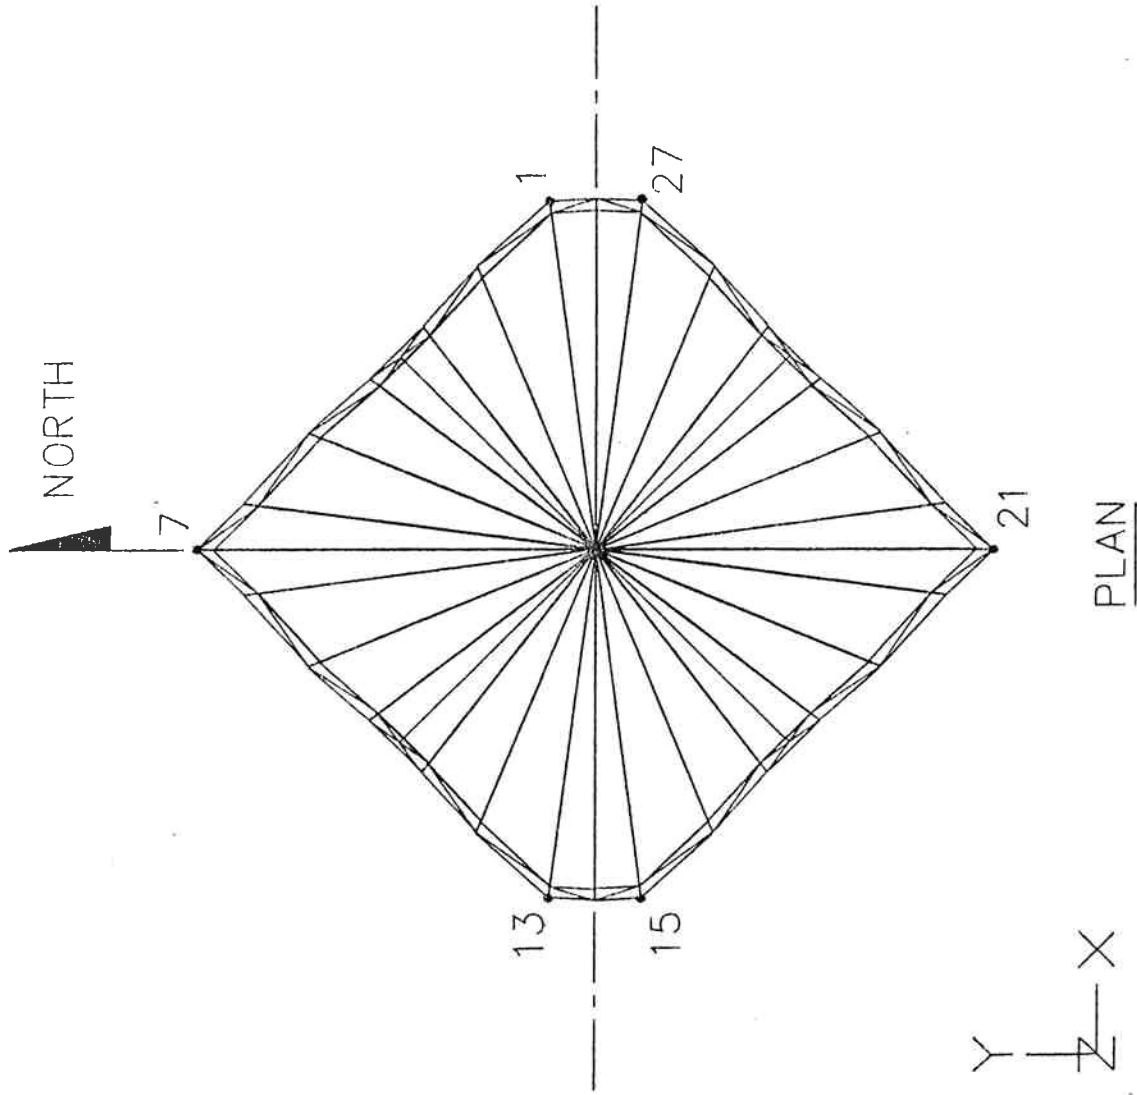
FIGURE 1-1

The substructure partial model results may be graphically reviewed with Figures 1-1 through 1-15. Figure 1-1 illustrates the diamond truss plan with the radial links. The partial model Y-axis corresponds to the North-South axis. It identifies the locations at which the radial ribs intersect with the diamond and trunnion trusses. Note that in the Half Model, the vertical axis

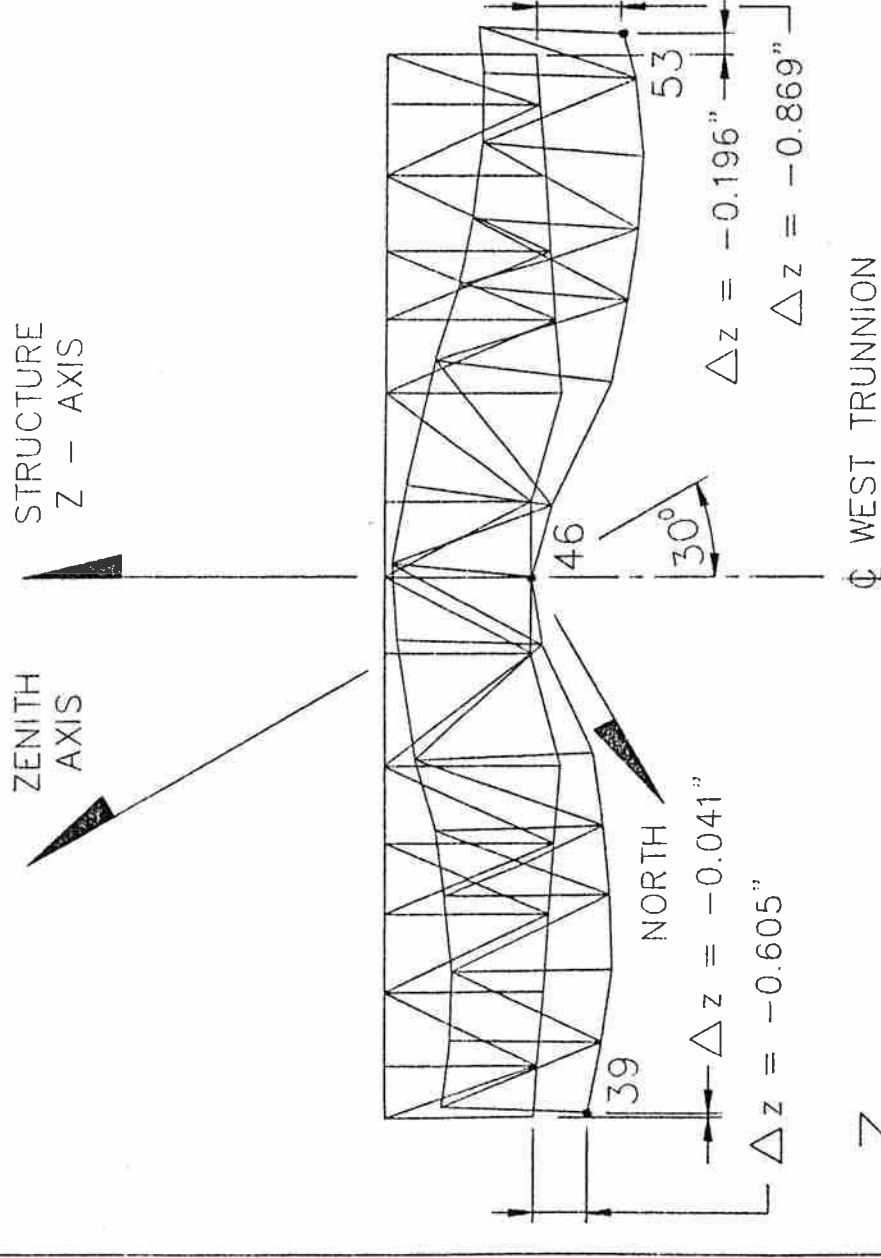
FIGURE 1-7

WEST ELEVATION WITH 30° INCLINED
DISH POSITION DEFLECTIONS

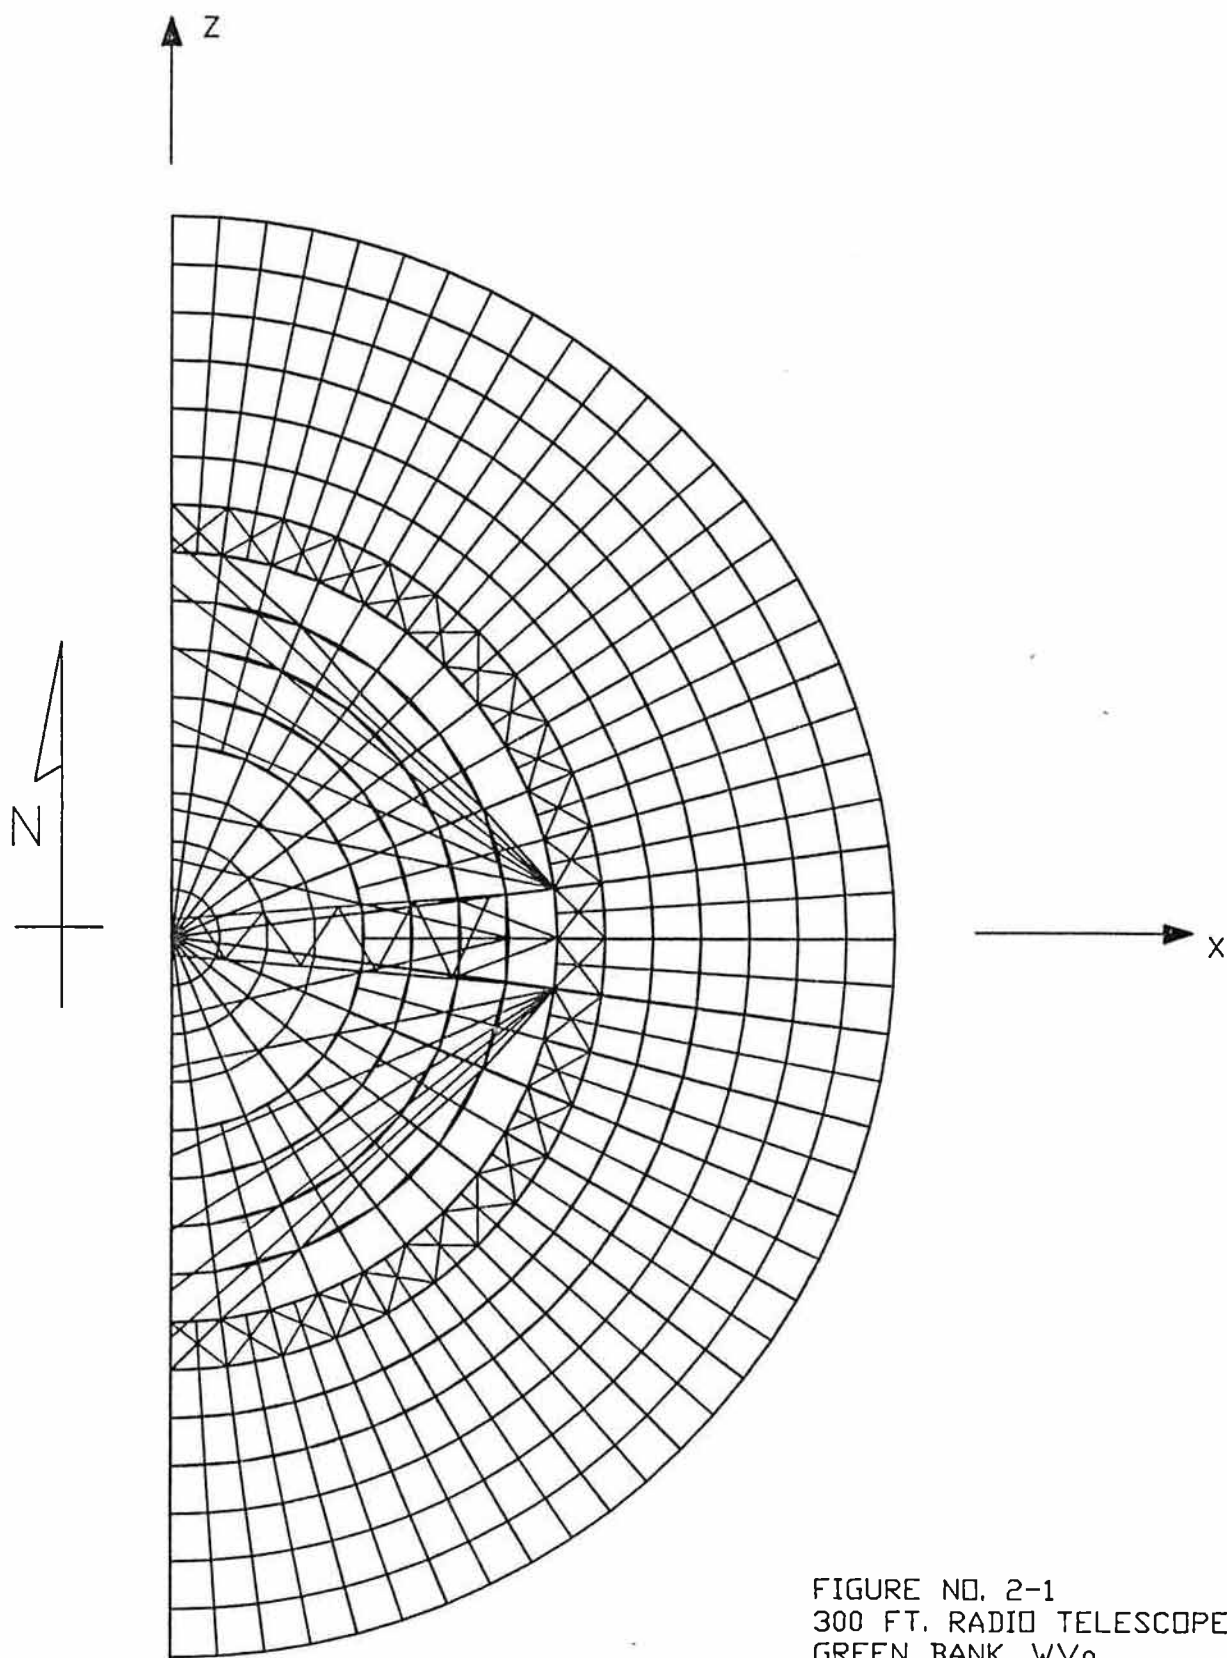
FIGURE NO. 2-1
300 FT. RADIO TELESCOPE
GREEN BANK, WV.
HALF MODEL PLAN

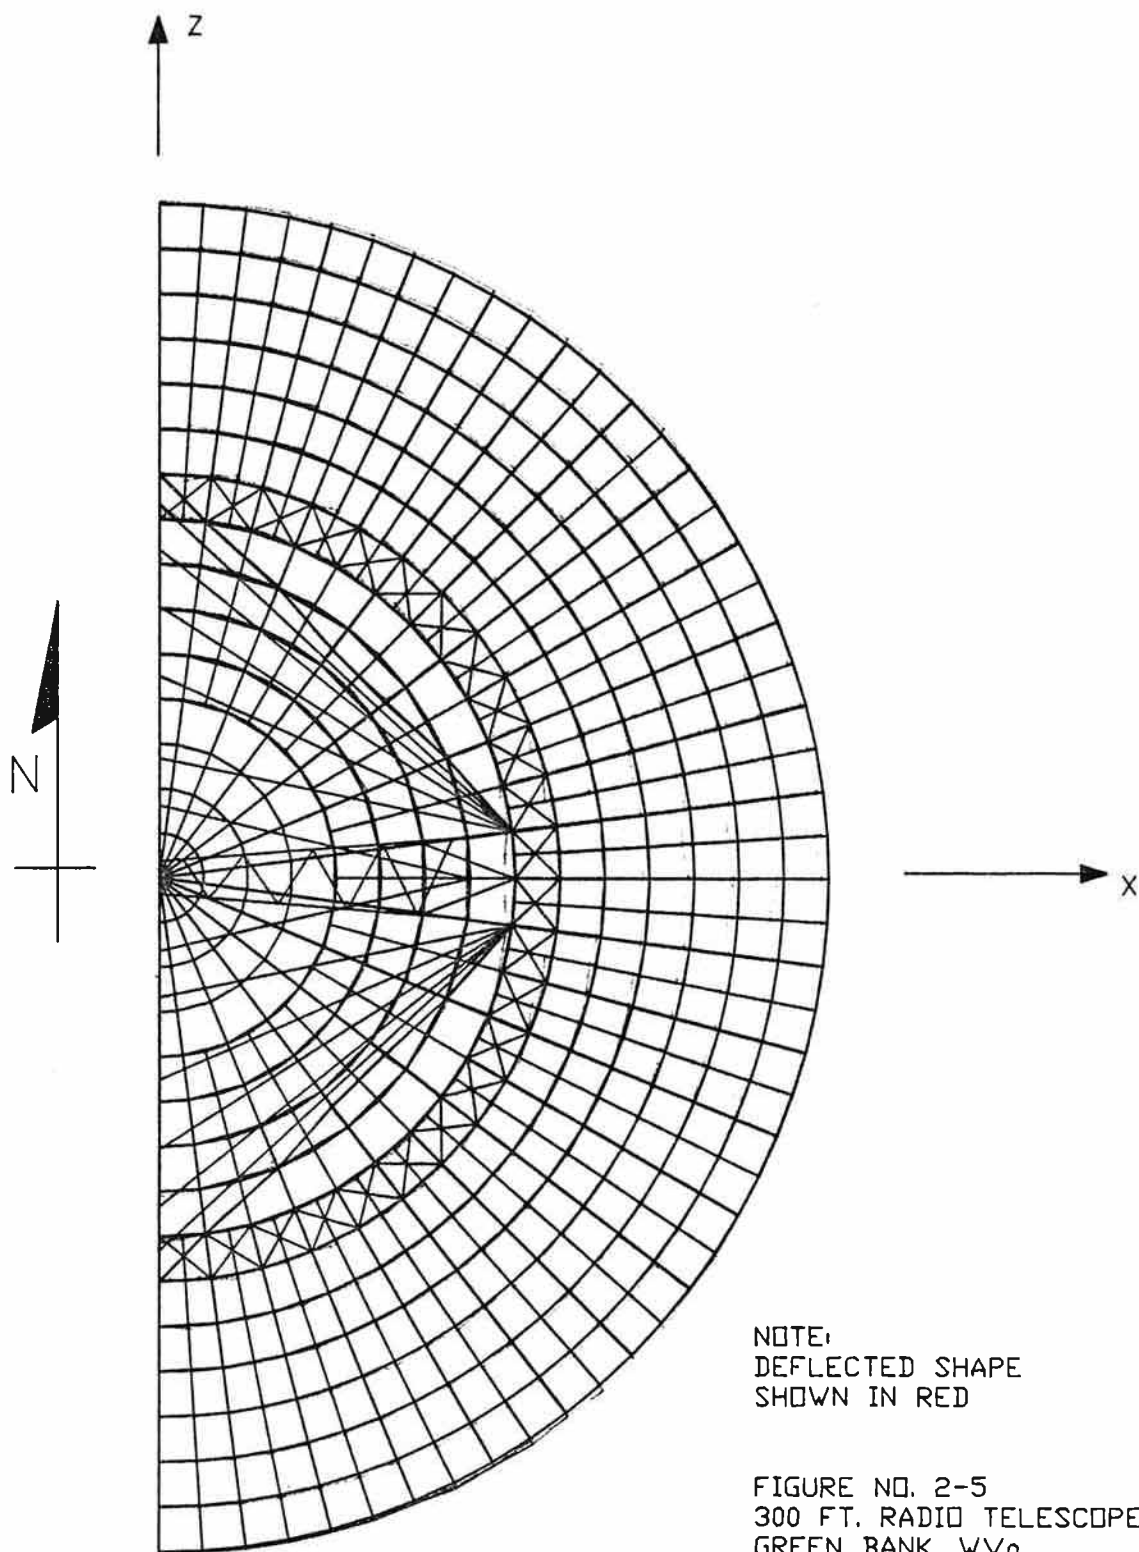
The deflection plots mentioned above were produced with AUTOCAD. They were based on the unloaded and loaded geometry information from the STAAD analysis. They are illustrated on Figures 2-5 through 2-7 for the zenith position analysis, and Figures 2-8 and 2-9 for the 45 degree inclined position analysis.

FIGURE NO. 2-5
300 FT. RADIO TELESCOPE
GREEN BANK, WV.
HALF MODEL ZENITH POSITION DEFLECTIC
PLAN

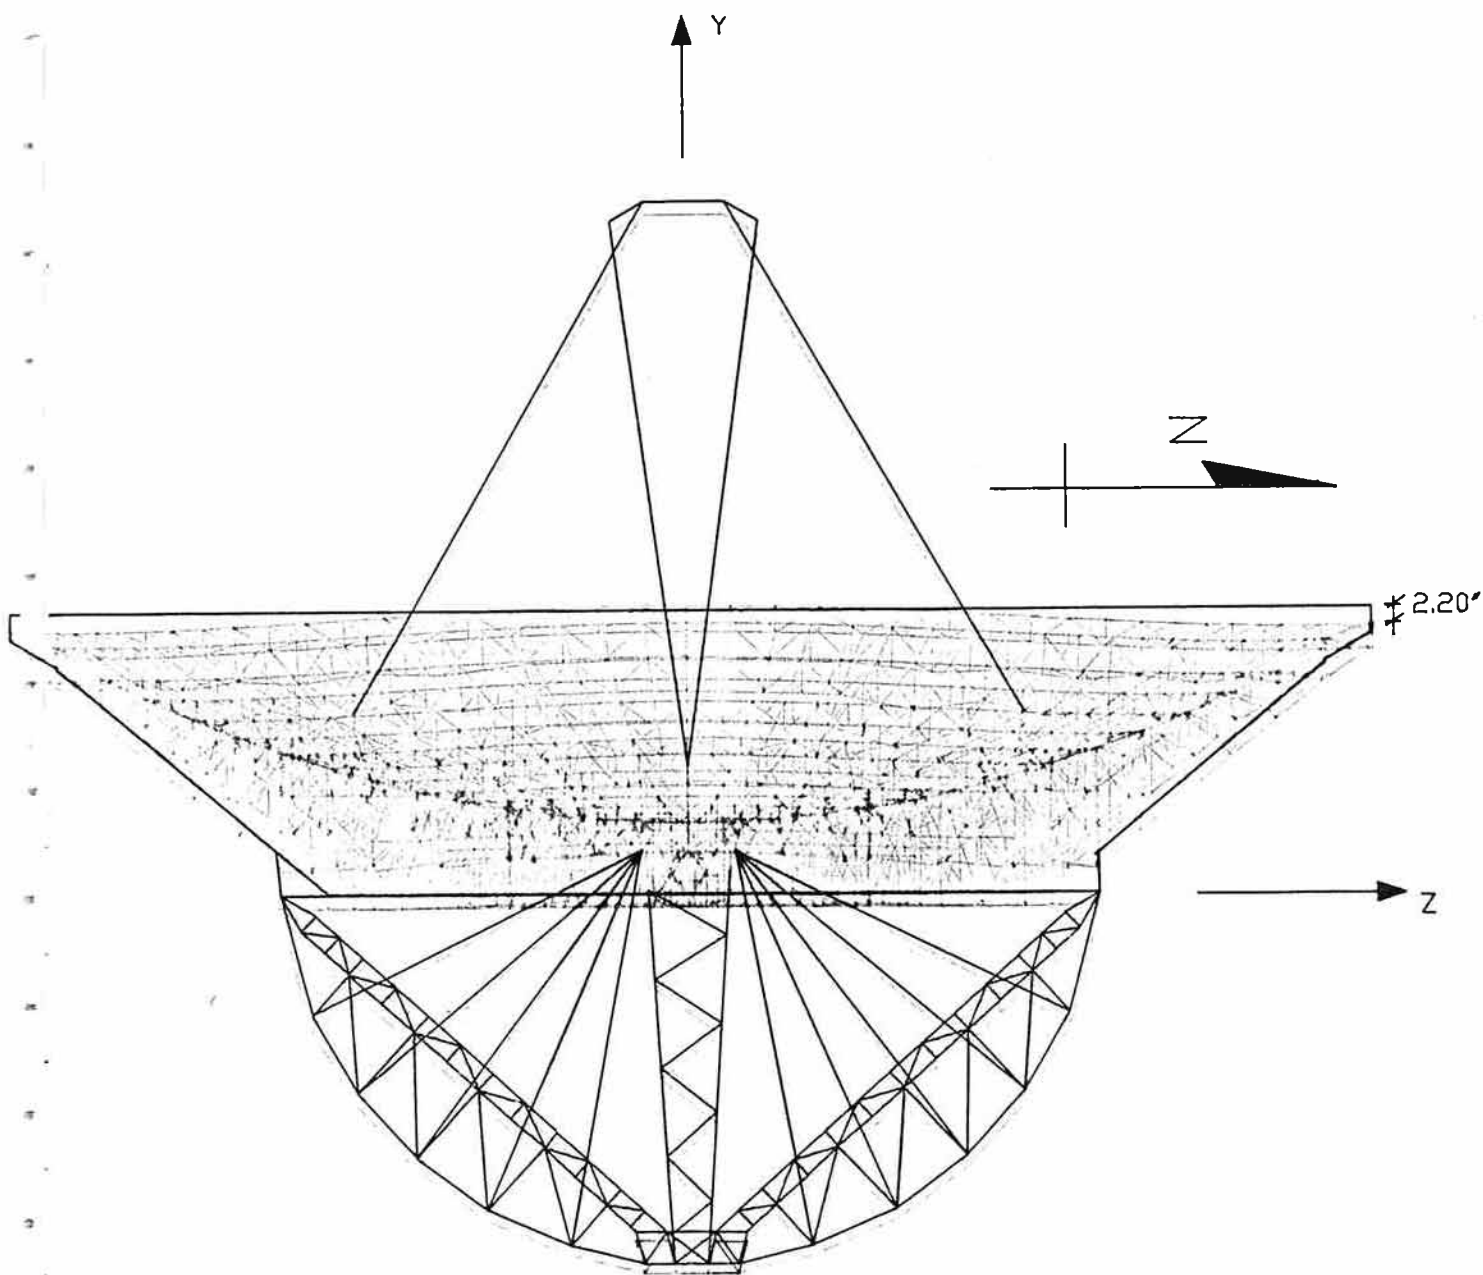
FIGURE NO. 2-7
300 FT. RADIO TELESCOPE
GREEN BANK, WVa.
HALF MODEL ZENITH POSITION DEFLECTIONS,
ELEVATION LOOKING WEST

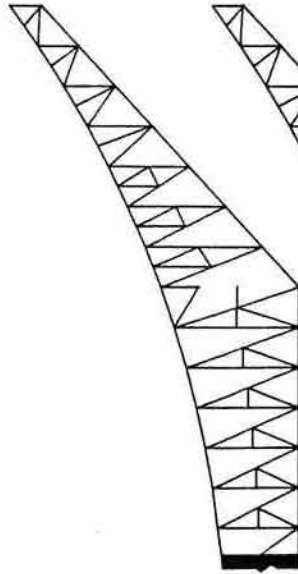
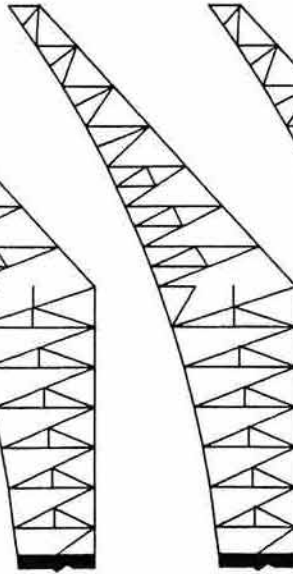
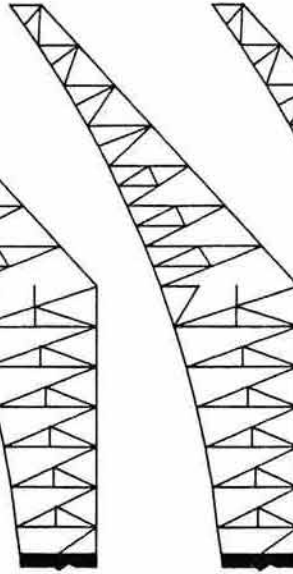
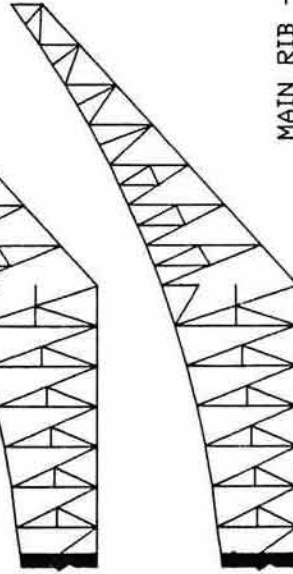
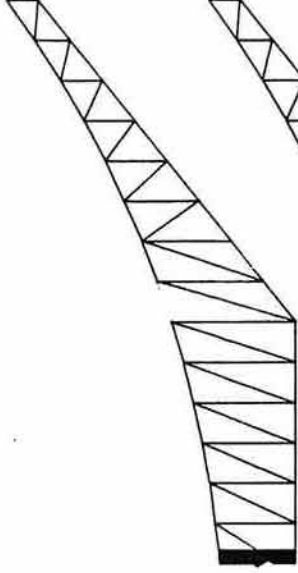
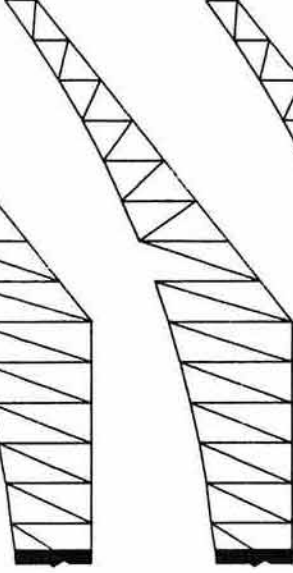
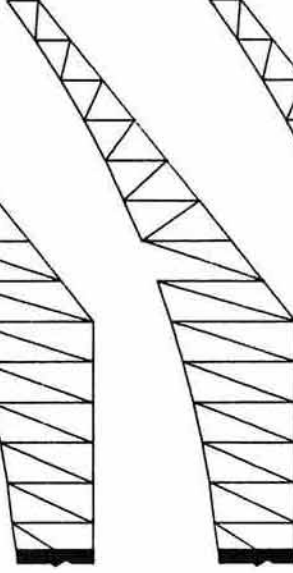
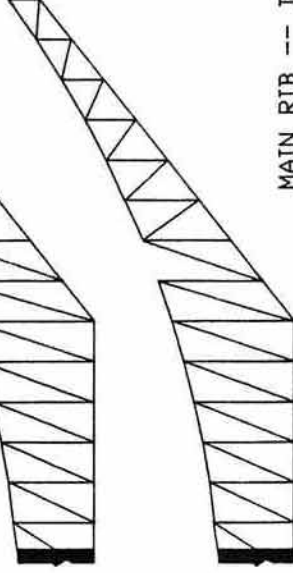
OVERSTRESSED MEMBERS
per AISC CODE EIGHTH
EDITION:

FIGURE NO. 2-12
300 FT. RADIO TELESCOPE
GREEN BANK, WV^a.
MAIN RIBS, A & D
MEMBER OVERSTRESSES,
ZENITH POSITION

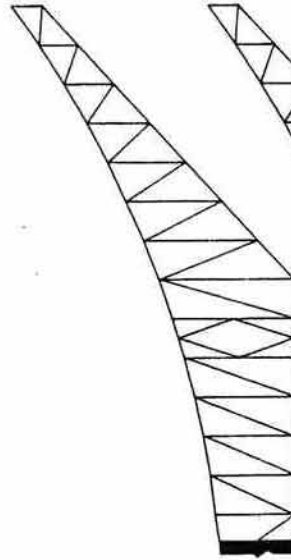
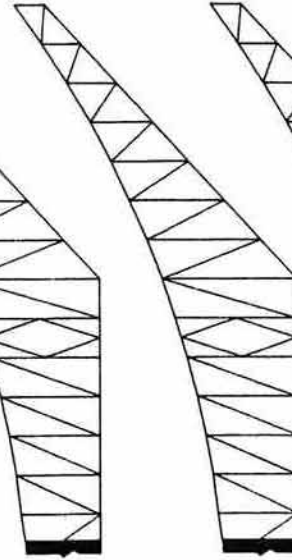
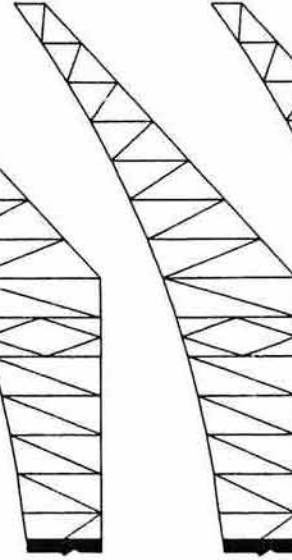
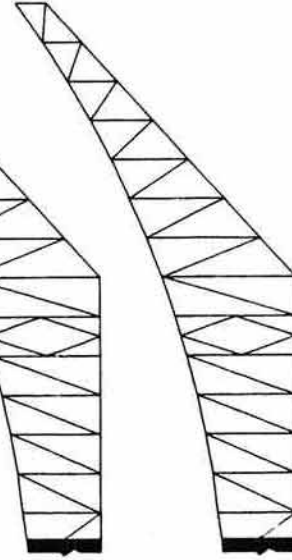
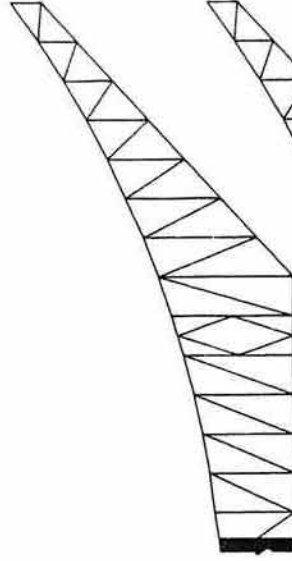
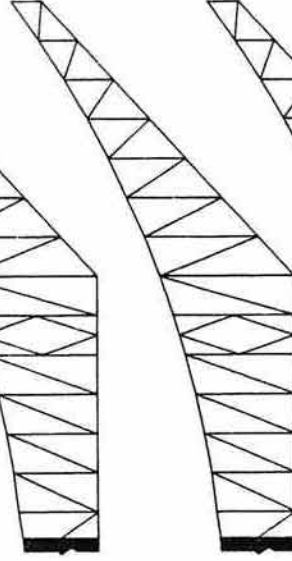
FIGURE NO. 2-14
300 FT. RADIO TELESCOPE
GREEN BANK, WV a.
MAIN RIBS C
MEMBER OVERSTRESSES,
ZENITH & 45° INCLINED
DISH POSITIONS

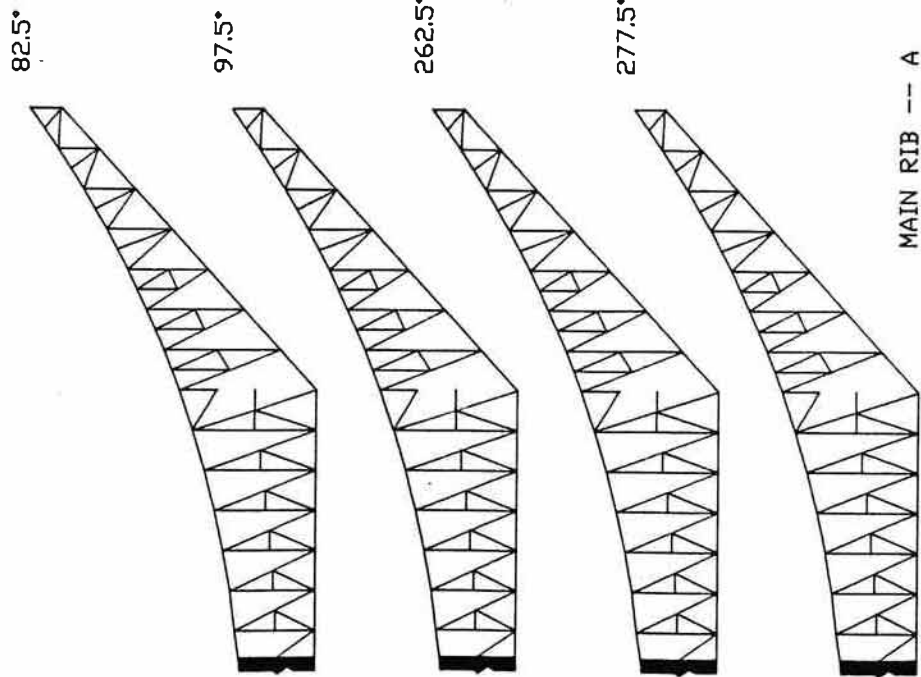
FIGURE NO. 2-15
300 FT. RADIO TELESCOPE
GREEN BANK, WV^a.
MAIN RIBS, A & D
MEMBER OVERSTRESSES,
45° INCLINED DISH POSITION

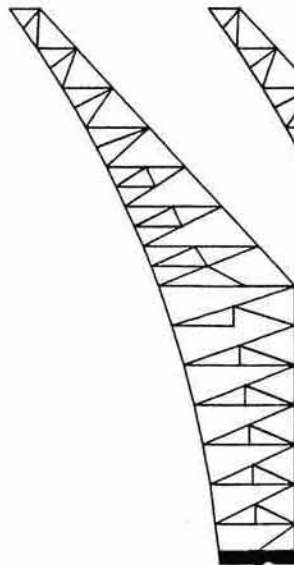
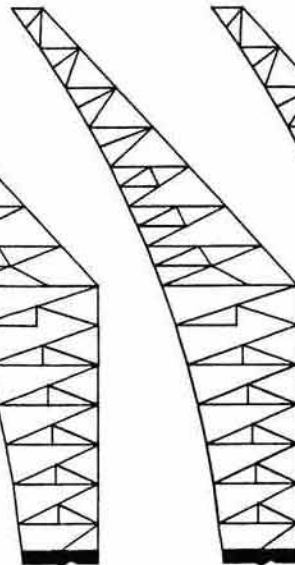
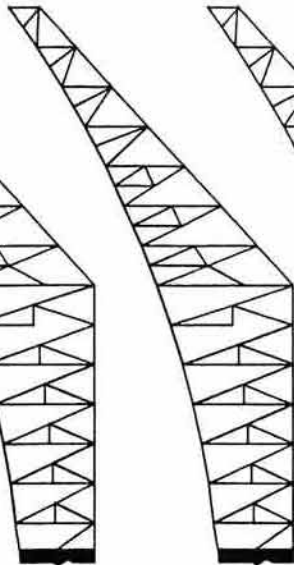
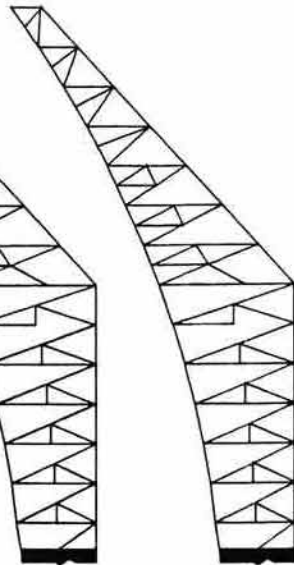
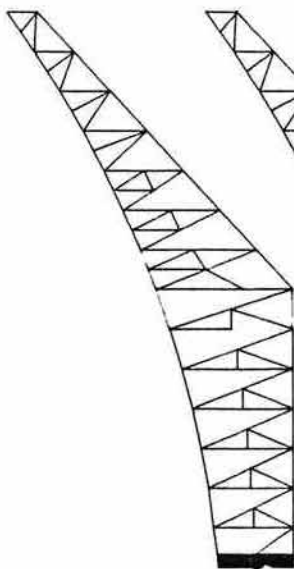
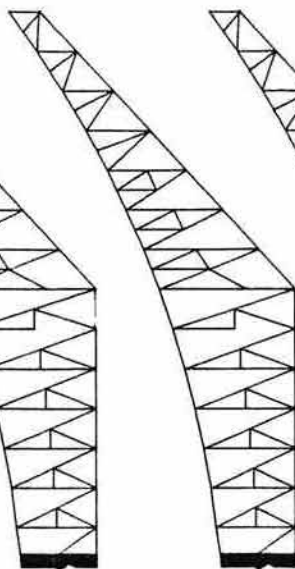
FIGURE NO. 2-16
RADIO TELESCOPE
GREEN BANK, WV^a.
MAIN RIBS, B
MEMBER OVERSTRESSES,
45° INCLINED DISH POSITION

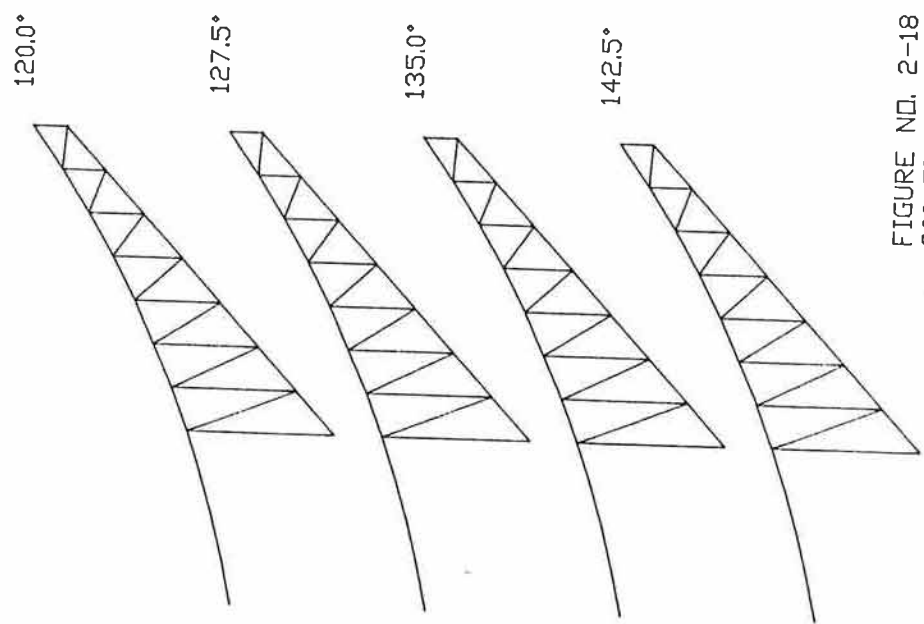
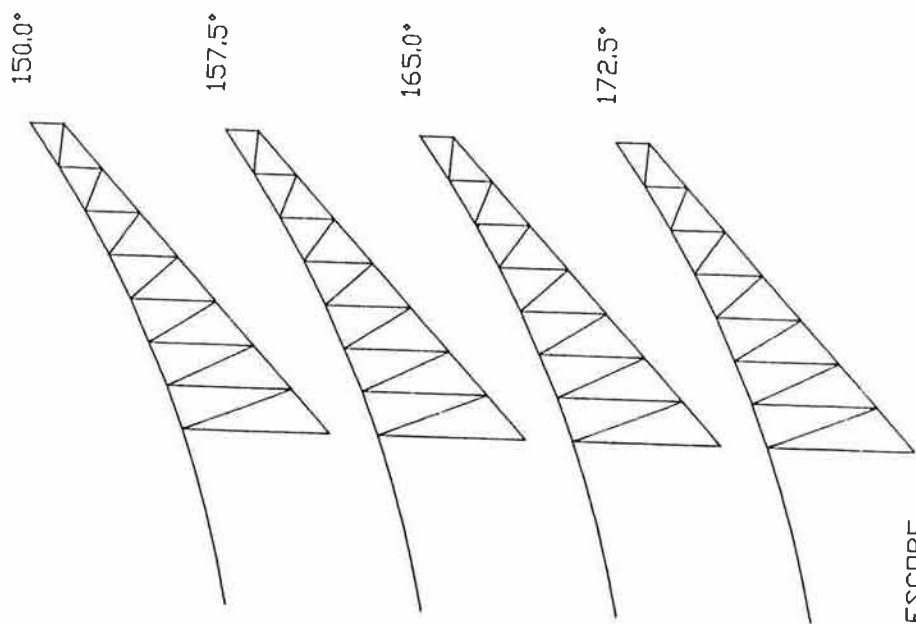
FIGURE NO. 2-18
300 FT. RADIO TELESCOPE
GREEN BANK, WV_a.
AUXILIARY RIBS
MEMBER OVERSTRESSES,
ZENITH & 45° INCLINED
DISH POSITIONS

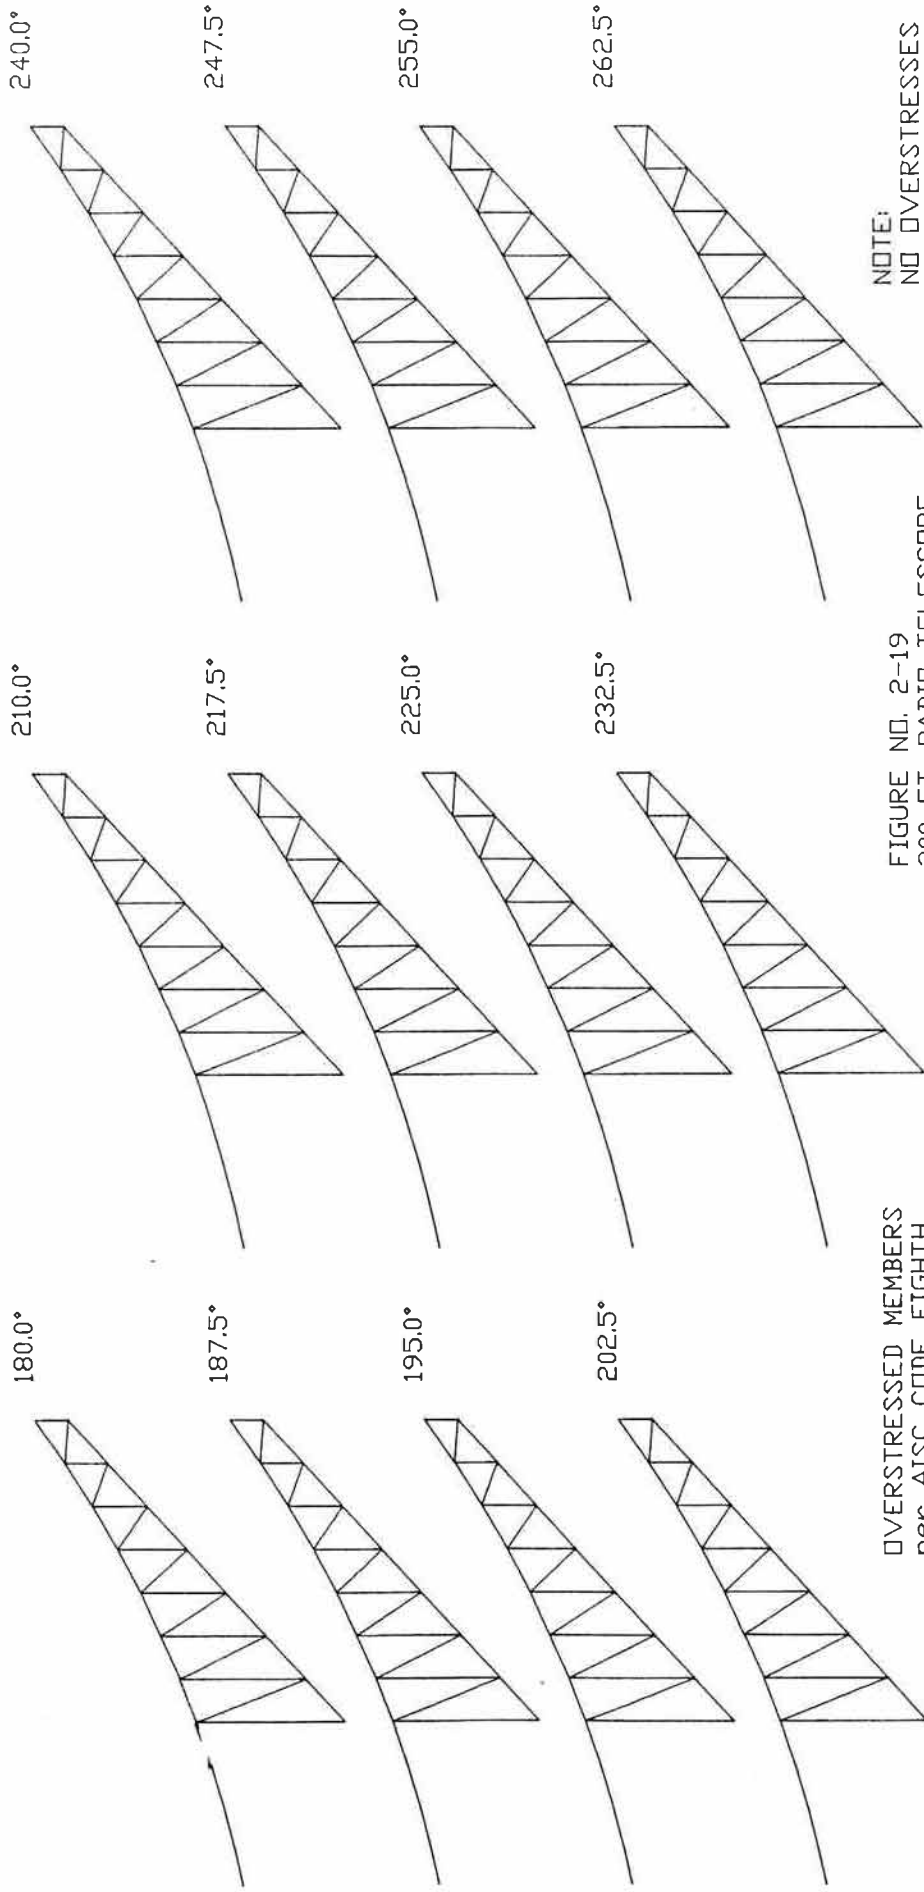
FIGURE NO. 2-19
300 FT. RADIO TELESCOPE
GREEN BANK, WV. a.
AUXILIARY RIBS
MEMBER OVERSTRESSES,
ZENITH & 45° INCLINED
DISH POSITIONS

NOTE:
NO OVERSTRESSES
DETERMINED IN 45°
INCLINED DISH
POSITION

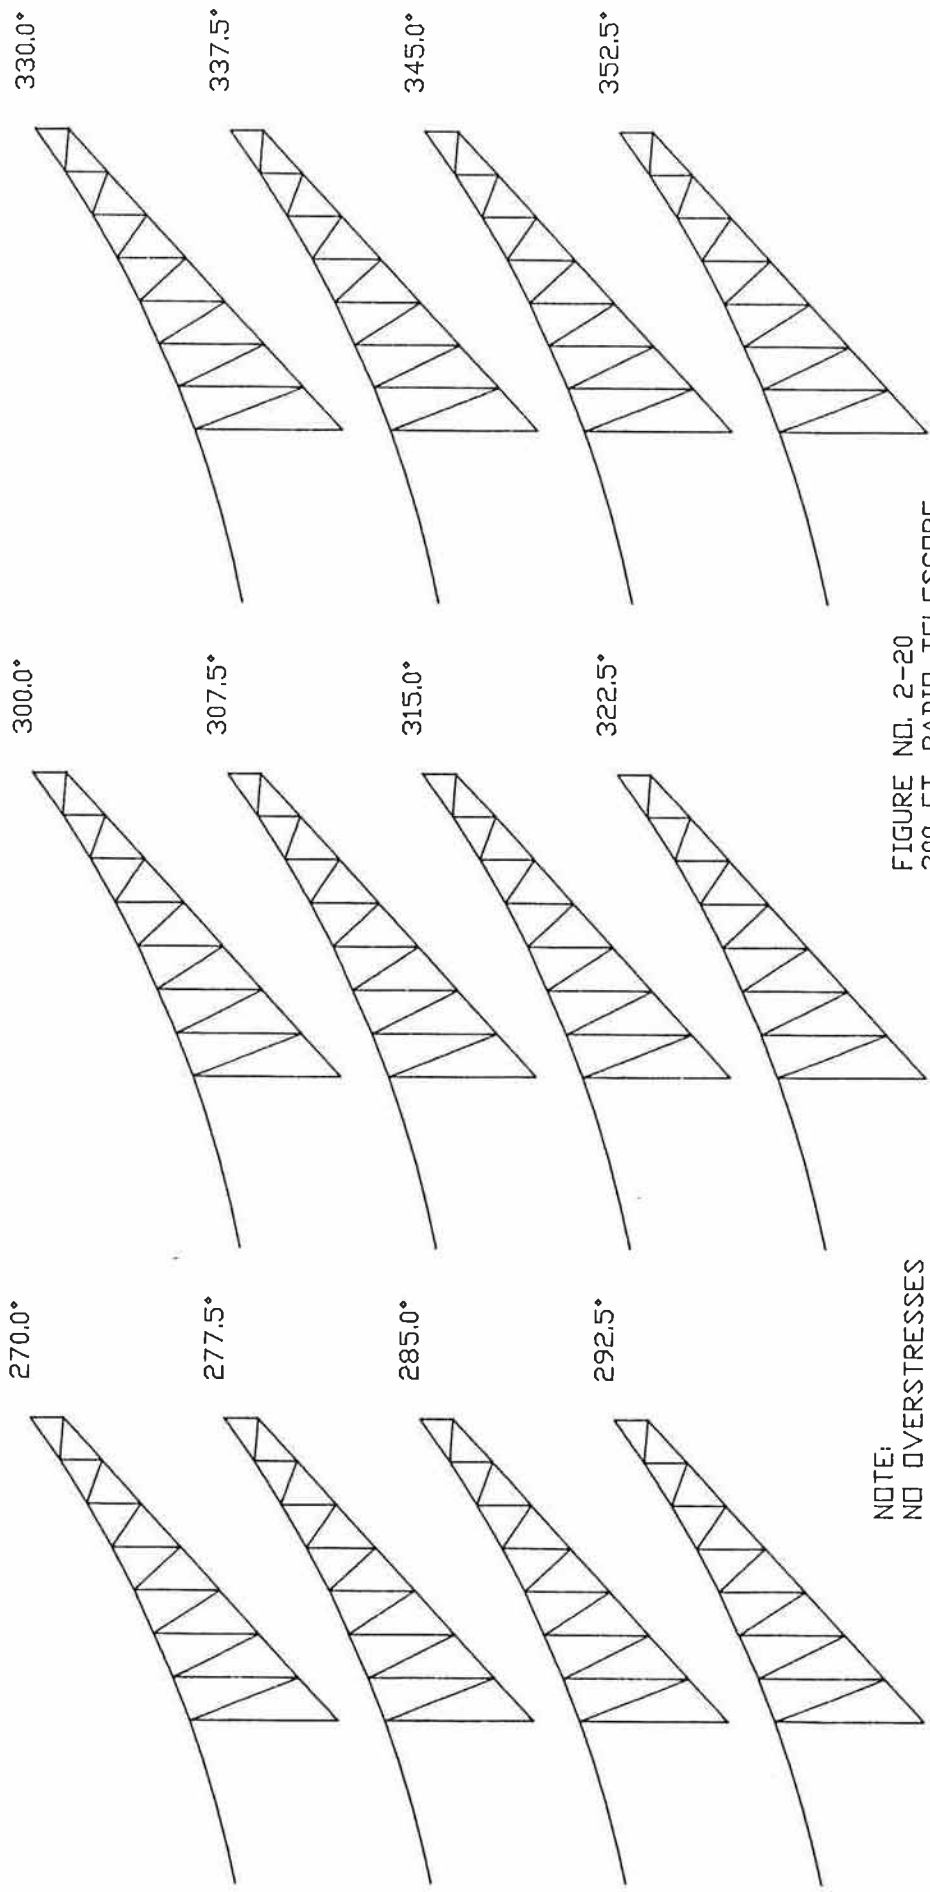
NOTE:
NO OVERSTRESSES
DETERMINED

FIGURE NO. 2-20
300 FT. RADIO TELESCOPE
GREEN BANK, WV/a.
AUXILIARY RIBS
MEMBER OVERSTRESSES,
ZENITH & 45° INCLINED
DISH POSITIONS

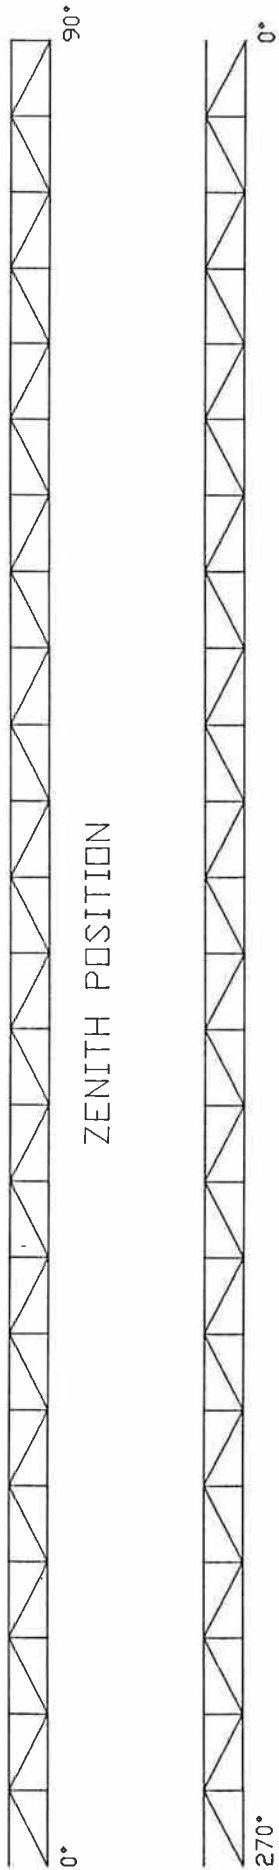
NOTE:
NO OVERSTRESSES
DETERMINED

FIGURE 2-21
300 FT. RADIO TELESCOPE
GREEN BANK, WV.
CIRCUMFERENCE 1
MEMBER OVERSTRESSES,
ZENITH & 45° INCLINED
DISH POSITIONS

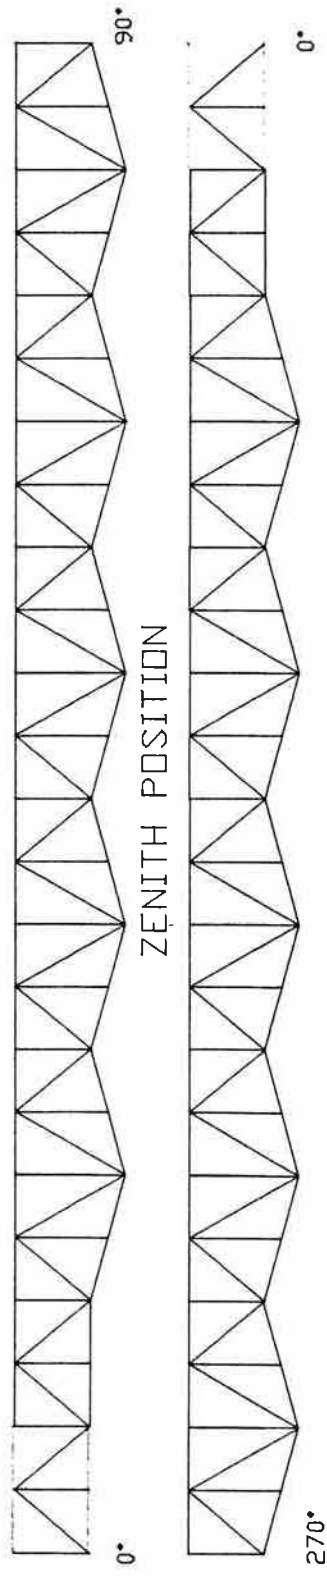
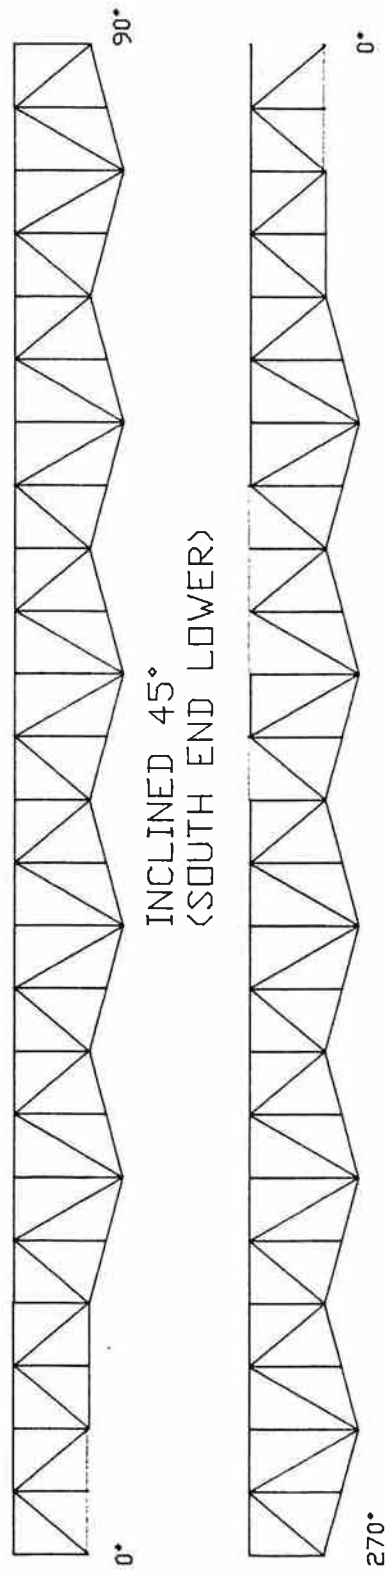
FIGURE NO. 2-24
300 FT. RADIO TELESCOPE
GREEN BANK, WV^a.
CIRCUMFERENCE 4,
MEMBER OVERSTRESSES,
ZENITH & 45° INCLINED
DISH POSITIONS

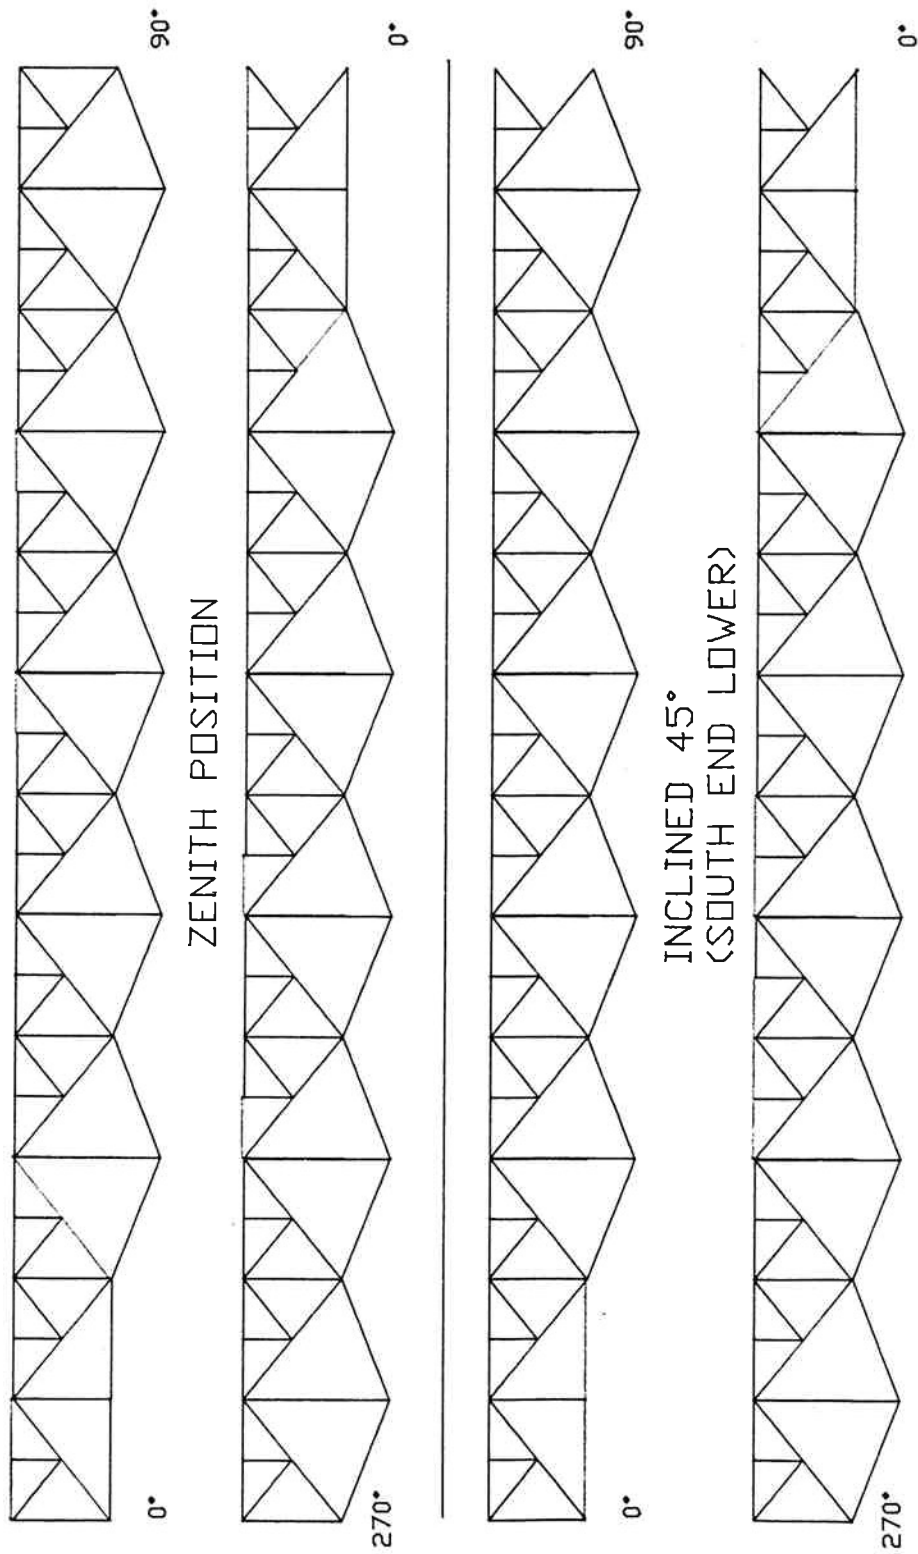
FIGURE NO. 2-25
 300 FT. RADIO TELESCOPE
 GREEN BANK, WV^a.
 CIRCUMFERENCE 5,
 MEMBER OVERSTRESSES
 ZENITH & 45° INCLINED
 DISH POSITIONS

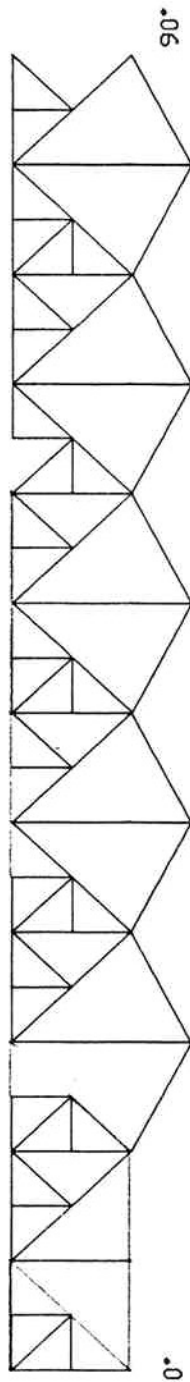
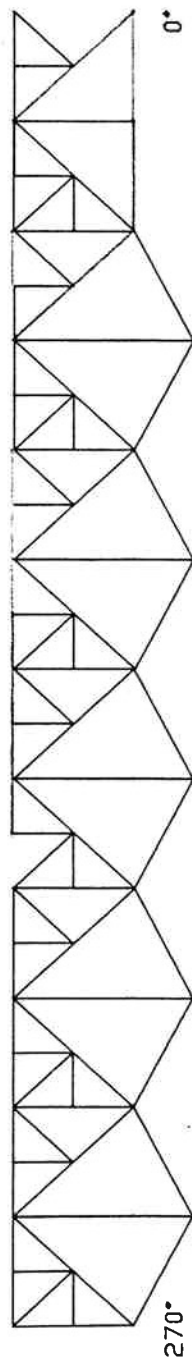
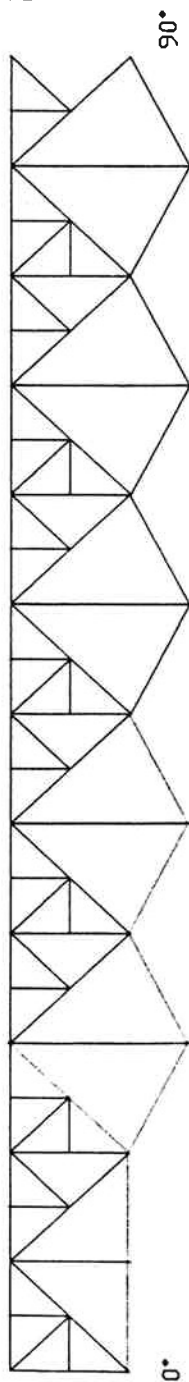
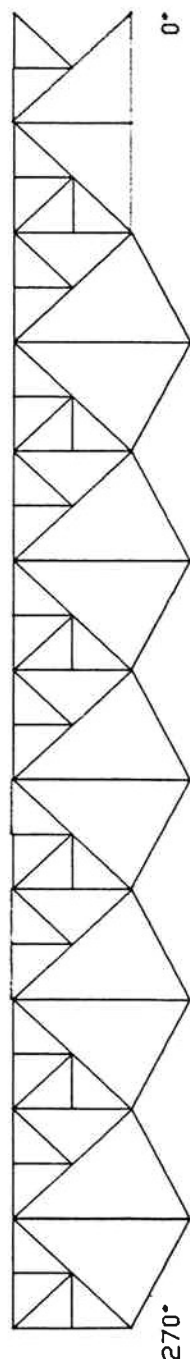
FIGURE NO. 2-26
300 FT. RADIO TELESCOPE
GREEN BANK, WV_a,
CIRCUMFERENCE 6,
MEMBER OVERSTRESSES,
ZENITH & 45° INCLINED
DISH POSITIONS

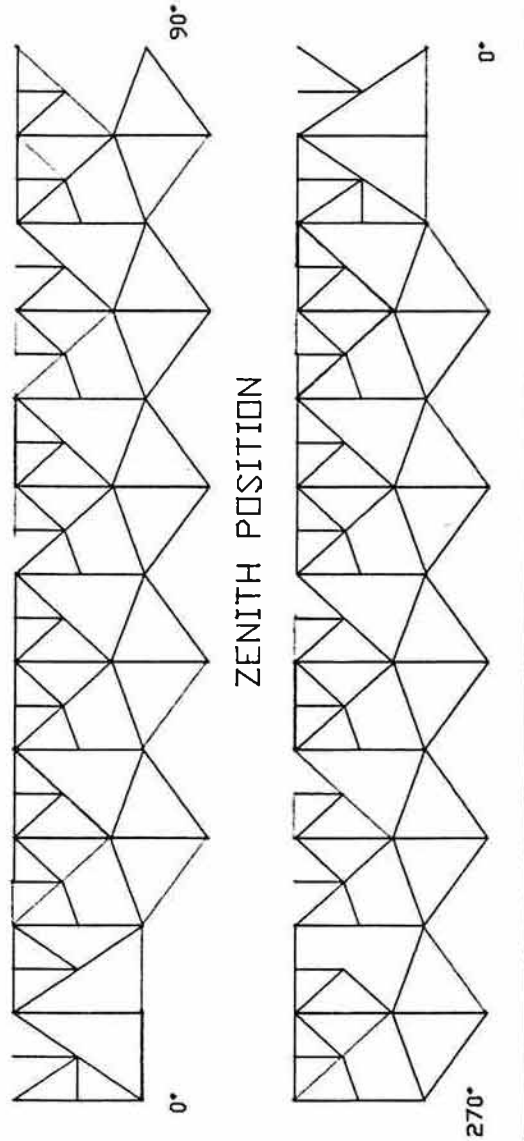
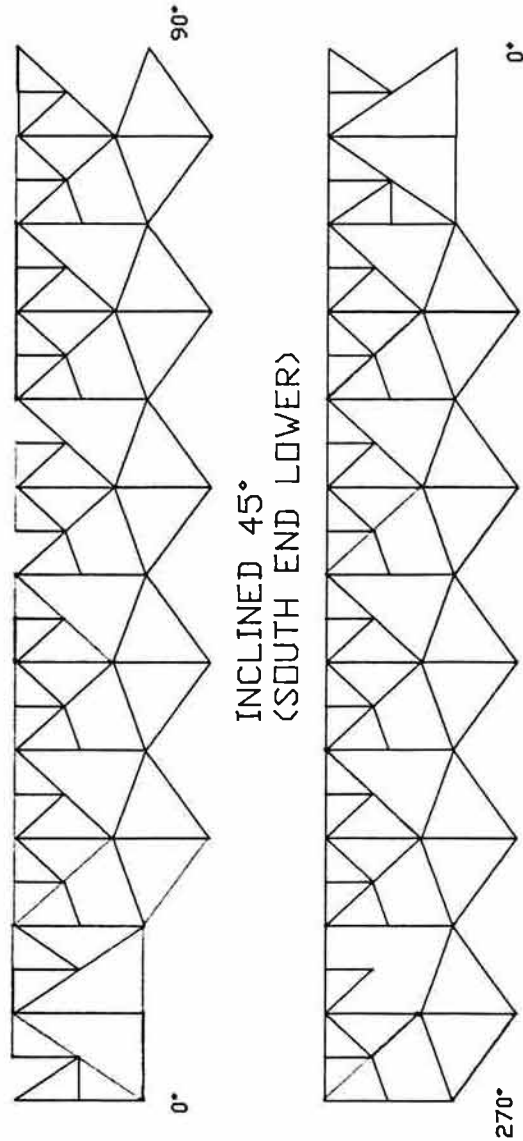
FIGURE NO. 2-27
 300 FT. RADIO TELESCOPE
 GREEN BANK, WV_a,
 CIRCUMFERENCE 7,
 MEMBER OVERSTRESSES
 ZENITH & 45° INCLINED
 DISH POSITION
