REPORT
OF THE
TECHNICAL ASSESSMENT PANEL

COLLAPSE OF THE 300 foot RADIO TELESCOPE

**REPORT of the TECHNICAL ASSESSMENT PANEL
for the
300 foot RADIO TELESCOPE at GREEN BANK, WV**

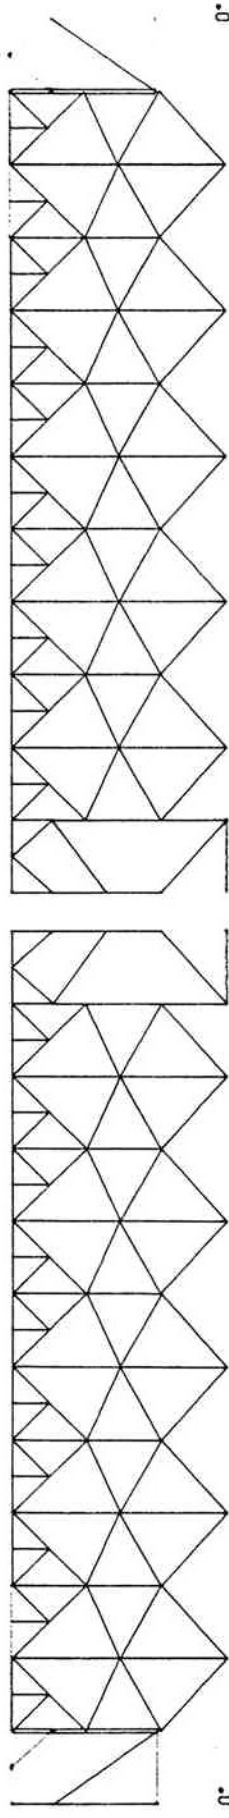
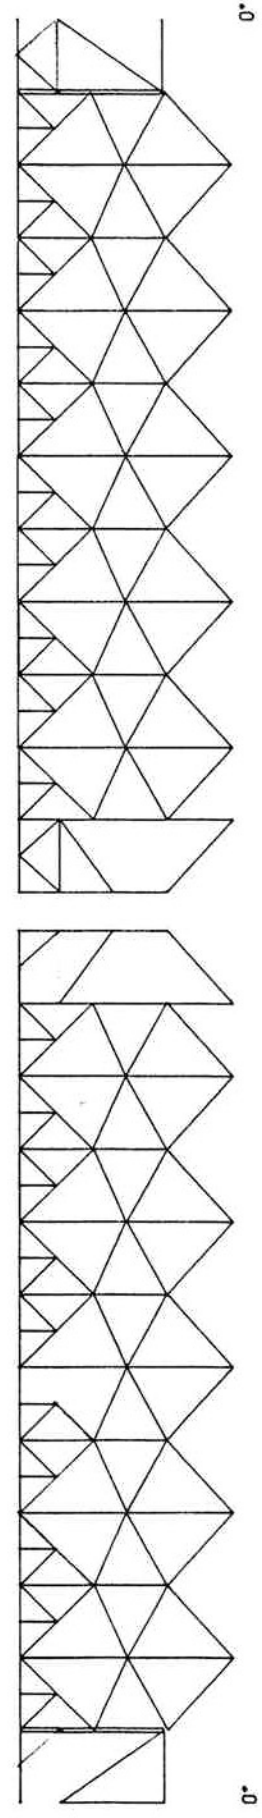
FIGURE 2-28
300 FT. RADIO TELESCOPE
GREEN BANK WV^a.
CIRCUMFERENCE 8,
MEMBER OVERSTRESSES
ZENITH & 45° INCLINED DISH POSITIONS

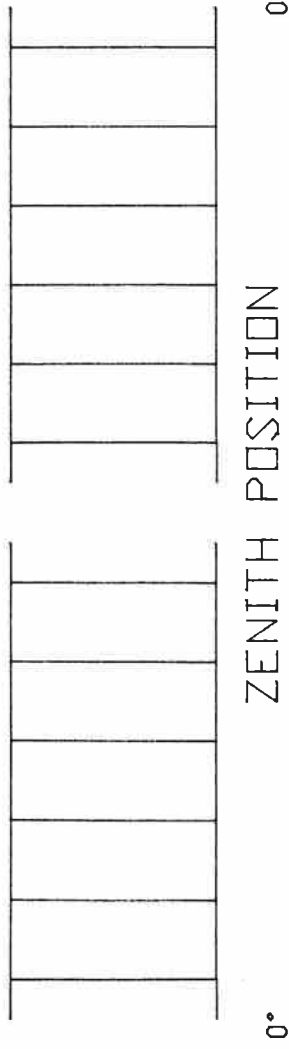
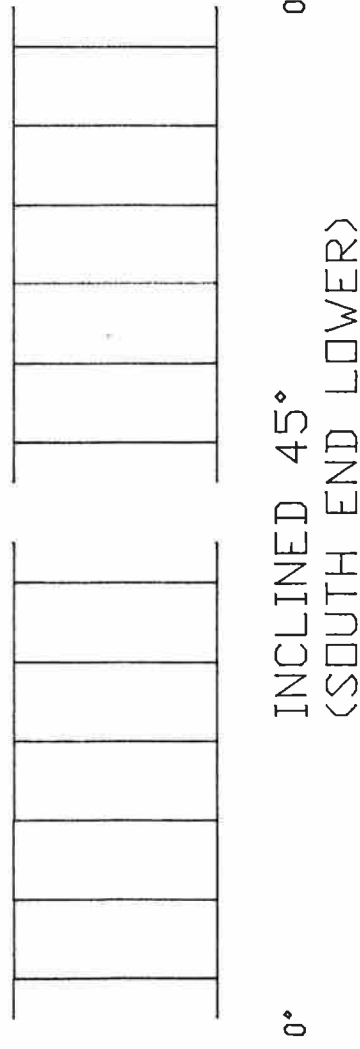
FIGURE NO. 2-32
 300 FT. RADIO TELESCOPE
 GREEN BANK WV_a.
 CIRCUMFERENCE 12
 MEMBER OVERSTRESSES,
 ZENITH & 45° INCLINED

NOTE:
 NO OVERSTRESSES
 DETERMINED

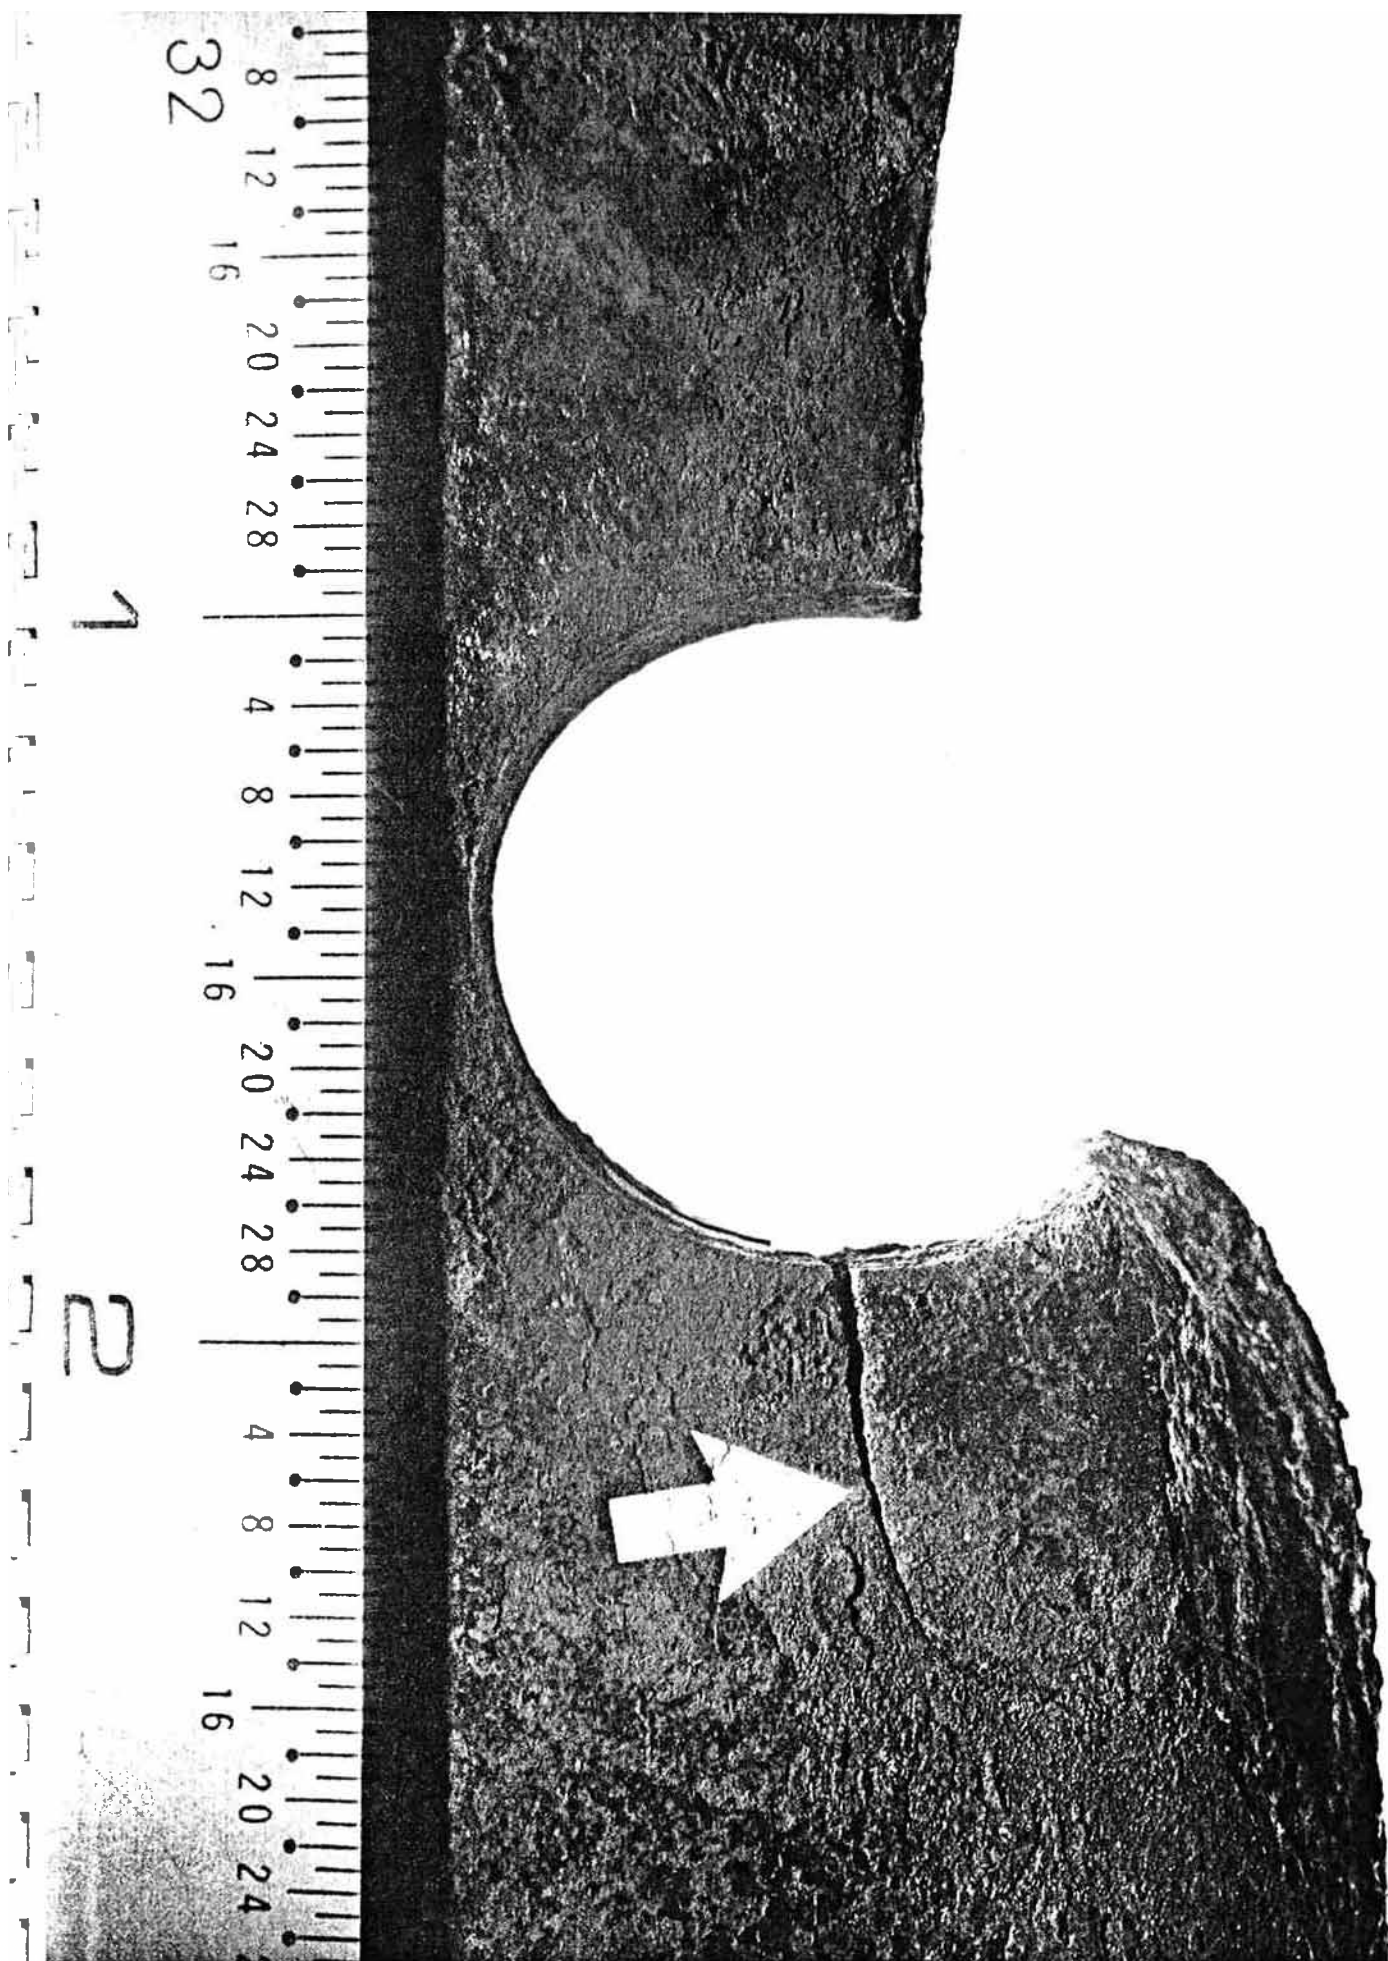
SECONDARY FATIGUE CRACK

Close-up photograph showing a secondary fatigue crack (arrow) parallel and adjacent to the primary fracture, as is characteristic of fatigue cracking under intermediate to high cyclic stresses.
